BAKÁS PILIPINAS

PHILIPPINE HISTORIC PRESERVATION SOCIETY

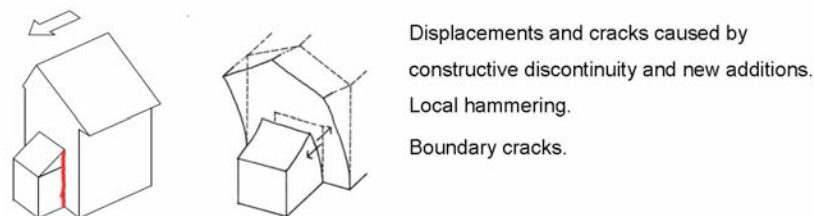
Figure 4. Movement of the main body of the church can cause of cracks at boundaries, especially from pounding or hammering of the addition by the main body of the building. From *NIKER 3.1 – Damage Abacus*.

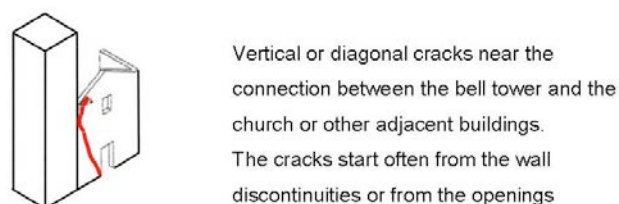
Figure 5. Typical location of cracks at intersection of bell tower with the nave from pounding during an earthquake. From *NIKER 3.1 – Damage Abacus*.

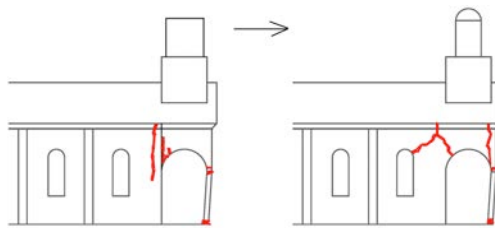
Figure 6. Typical crack damage at the corner of the side elevations and front facade or portico from rocking of the bell tower and portico during an earthquake.

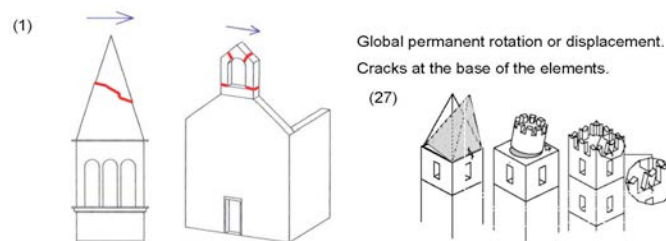
Figure 7. Vertical elements can crack and be displaced from earthquakes. From *NIKER 3.1 – Damage Abacus*.

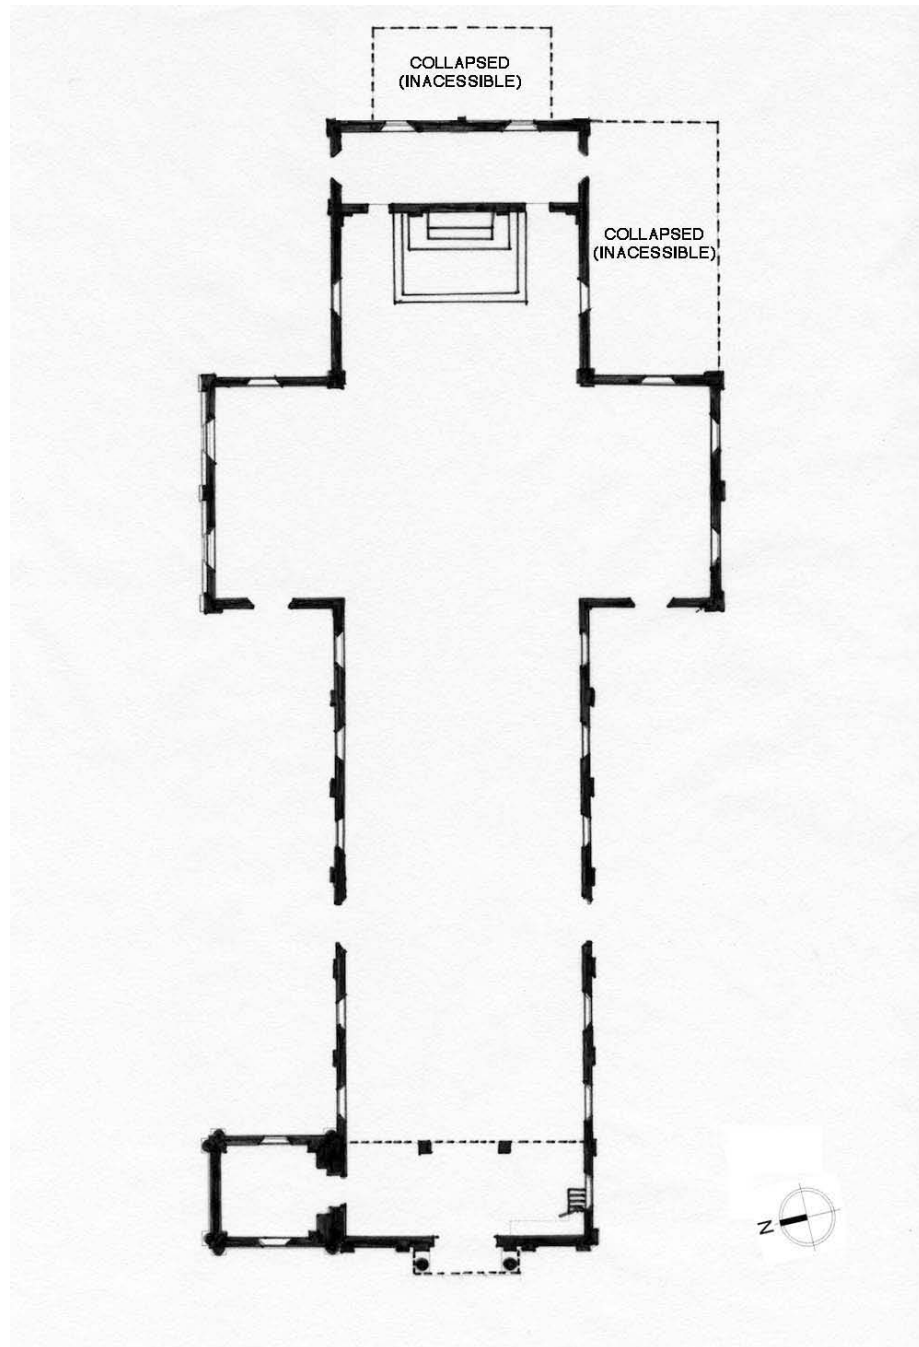
Figure 8. Ground floor plan of Nuestra Señora del Rosario Church, Antequera.

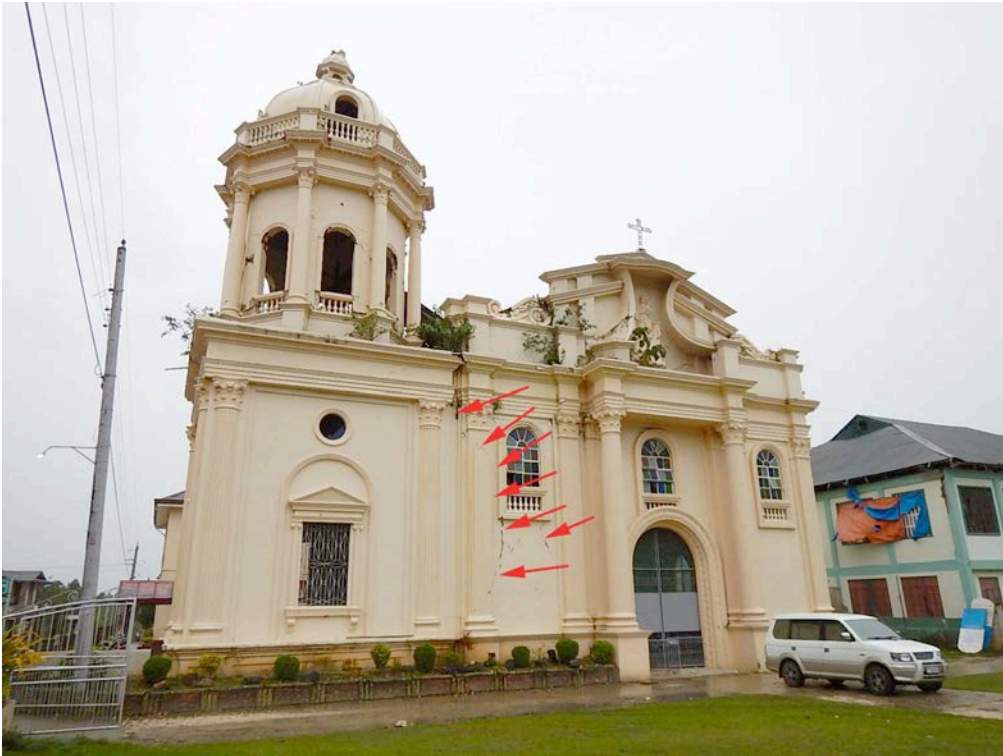
Figure 9. Front facade of Nuestra Señora del Rosario Church, Antequera, built of reinforced concrete over an older coralstone foundation. The front facade, which was constructed in the 1960s, is designed in the Baroque Revival style, with rococo features. There are cracks at the arrows, from rocking, and possibly pounding, from the bell tower. Note also plant growth at many locations above the cornice.

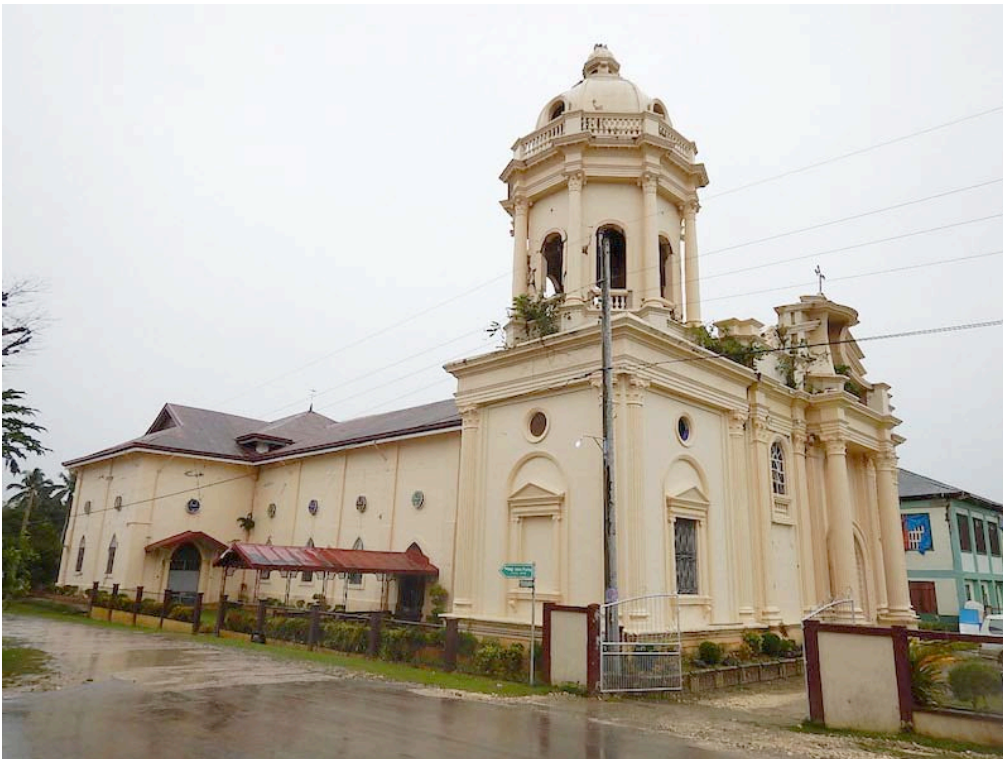
Figure 10. View of the northwest corner of the exterior, showing the bell tower cupola with its balustraded dome, and the north elevation and north transept.

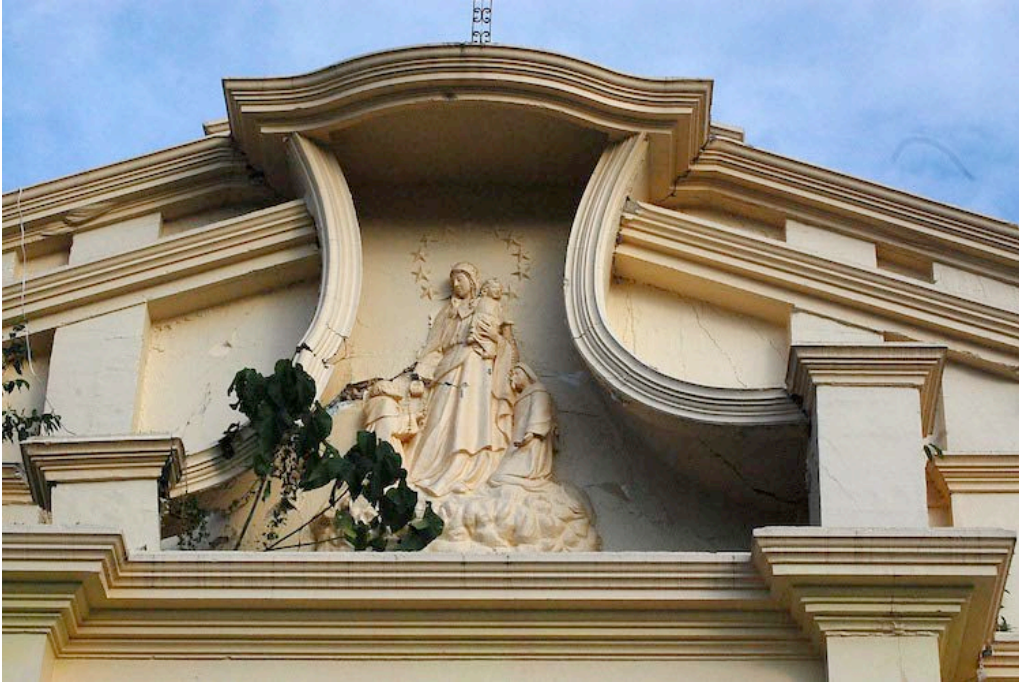
Figure 11. View of the highly articulated pediment over the front facade, exhibiting numerous cracks in all directions, probably from rocking motion. Plant growth in the pediment is a sign of the presence of moisture and soil.

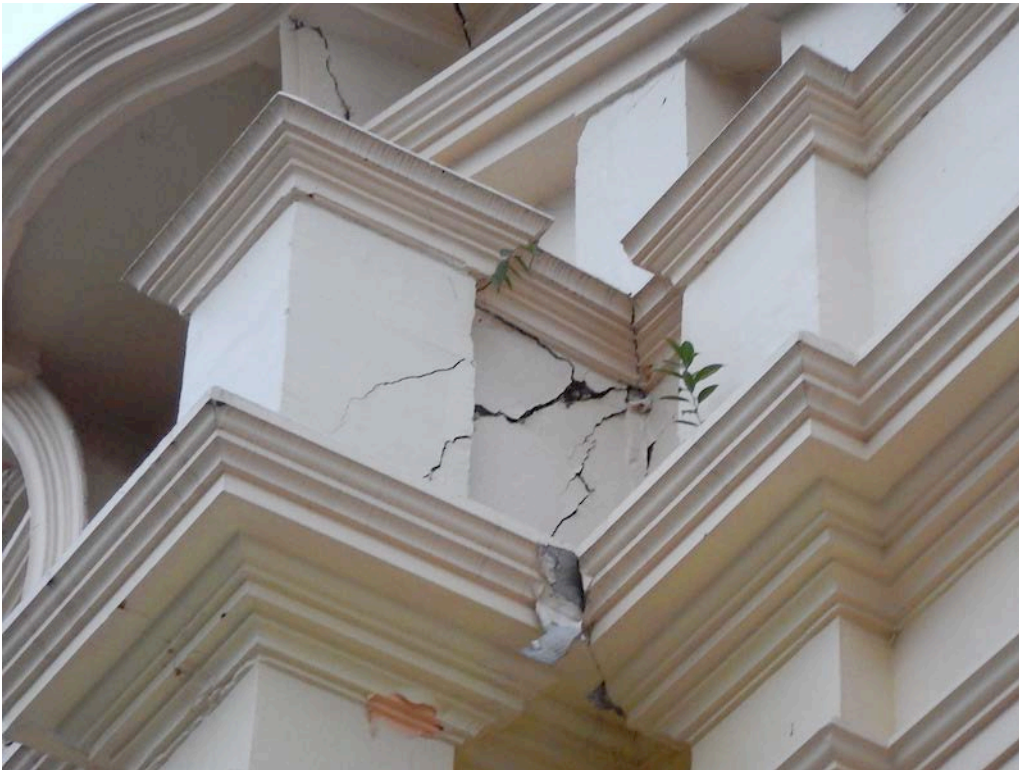
Figure 12. Another view of the pediment over the front facade showing diagonal cracks in the concrete, probably from rocking of the pediment.

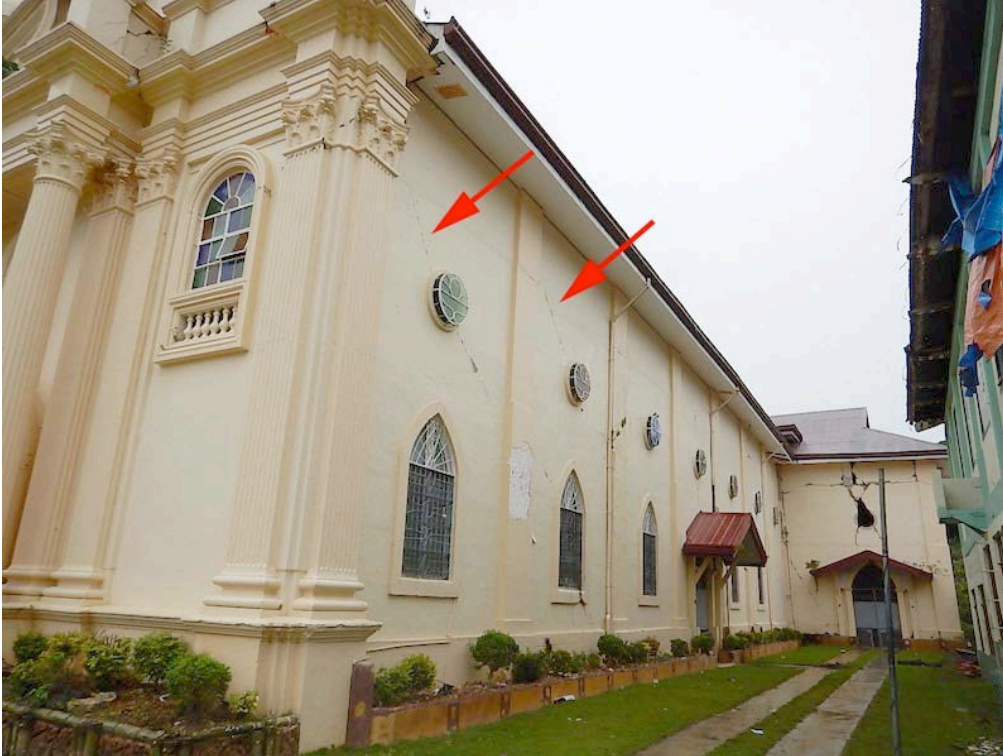
Figure 13. View of the southwest corner, and nave south side elevation and south transept, showing typical diagonal cracks at the arrows. See also fig. 28 for the interior view of the same cracks. The transept wall beyond is severely cracked, with horizontal cracks at a cold joint, and vertical cracks at the reentrant corner with the nave wall. The transept walls sustained more damage from the earthquake than the nave walls.

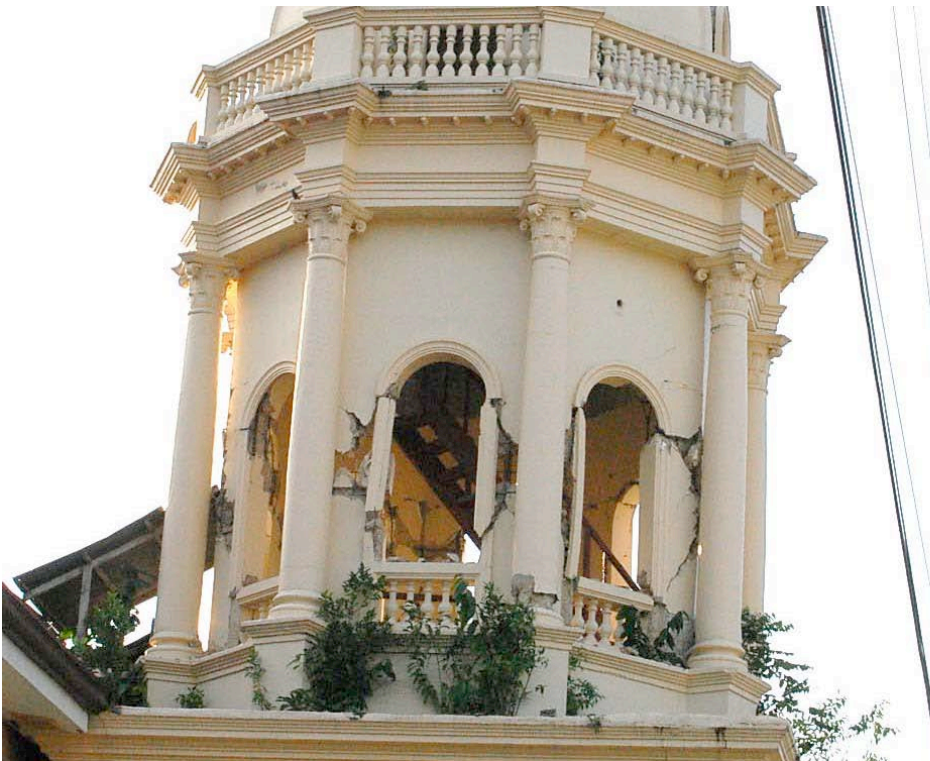
Figure 14. View of the bell tower cupola, exhibiting severe cracks of its hexagonal walls from rocking and possible twisting. Plant growth is abundant around the cupola. See fig. 22 for underside.

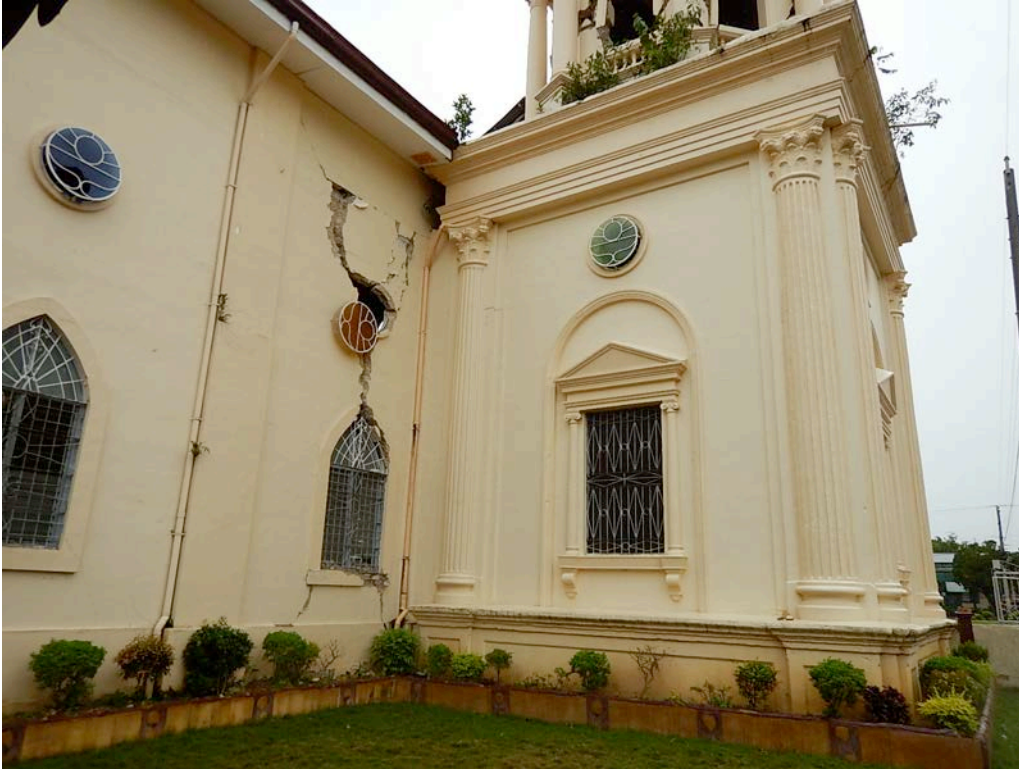
Figure 15. View of the corner where the bell tower is attached to the north nave wall. The cracking in the nave wall above the openings appears to have been caused by rocking of the bell tower and subsequent pounding.

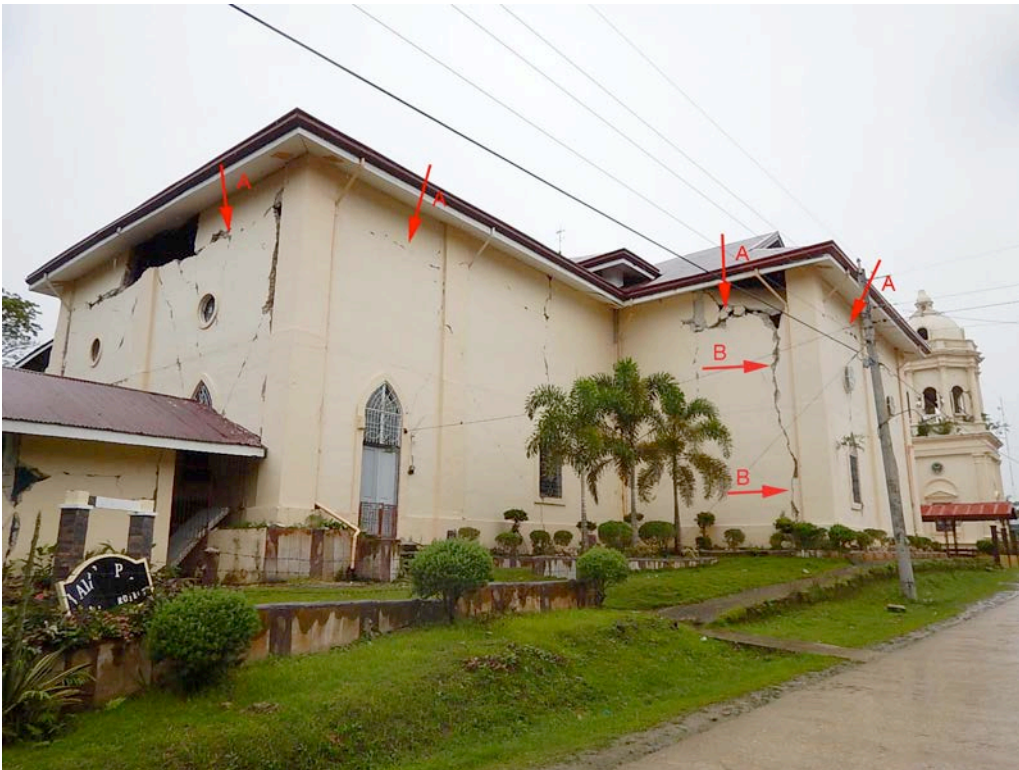
Figure 16. View of the northeast corner and north transept. The horizontal crack at “A” appears to be a cold joint boundary between two phases of construction. The vertical crack at “B” is likely due to overturning of the north transept wall.

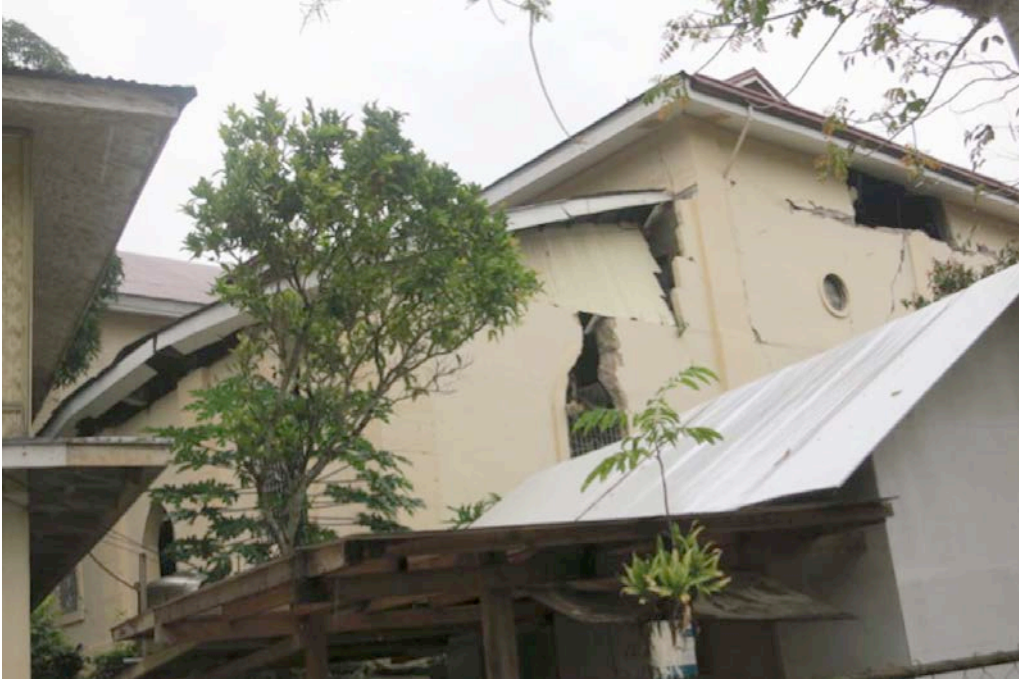
Figure 17. View of the southeast corner, where the roof has collapsed. See interior view in fig. 27.

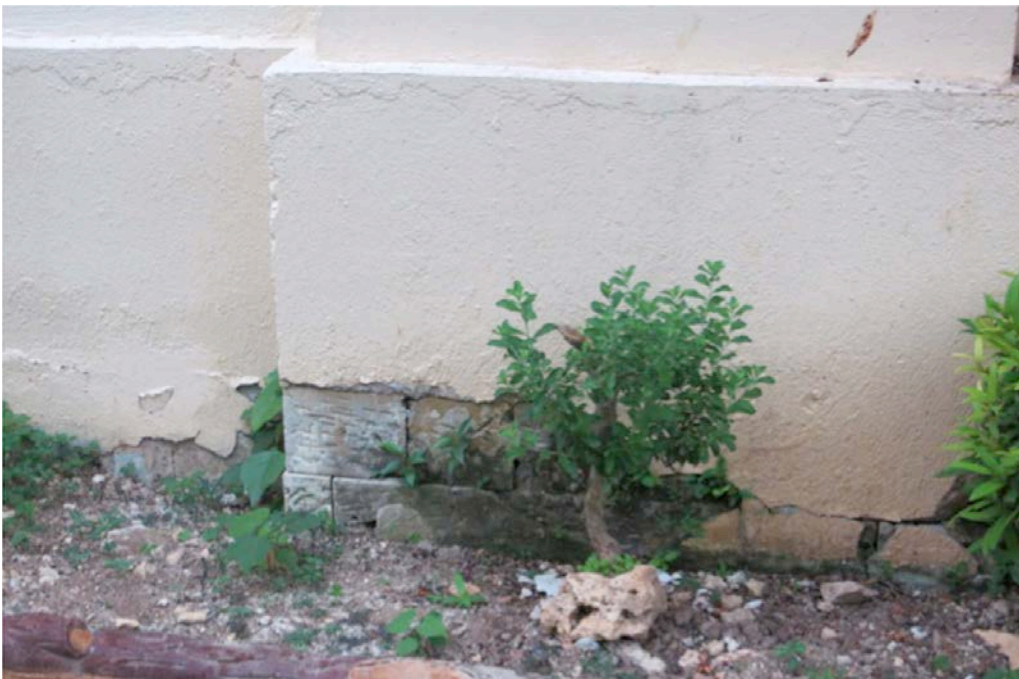
Figure 18. Exposed coralstone courses of the foundation wall, possibly dating from 1896.

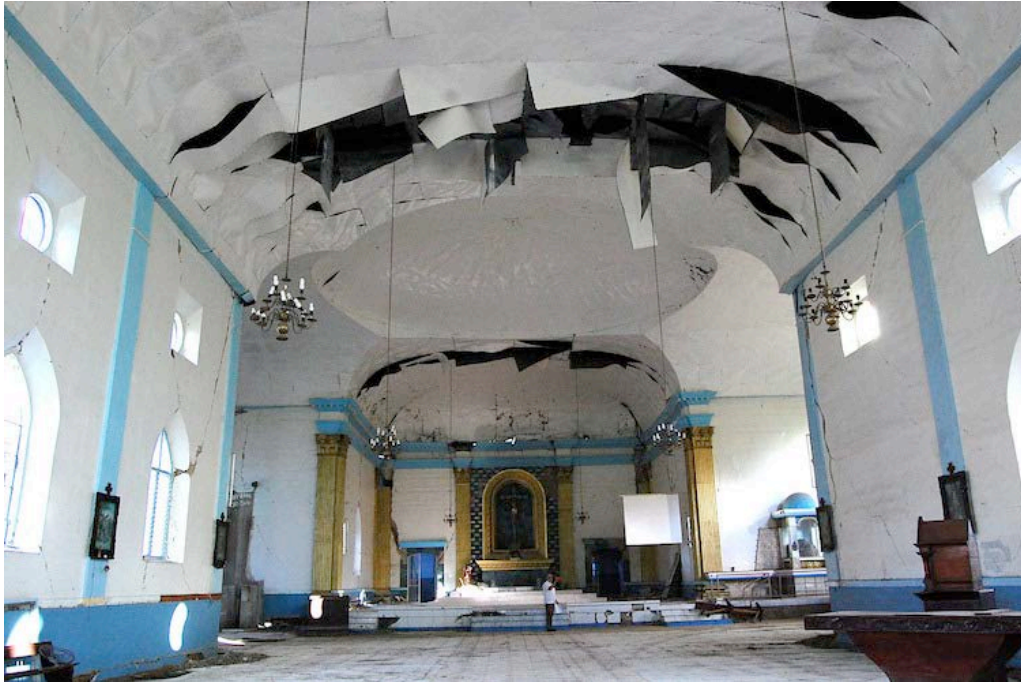
Figure 19. View of the church interior looking towards the altar. Note the vertical and diagonal cracks on all the walls and the falling sheet metal ceiling.

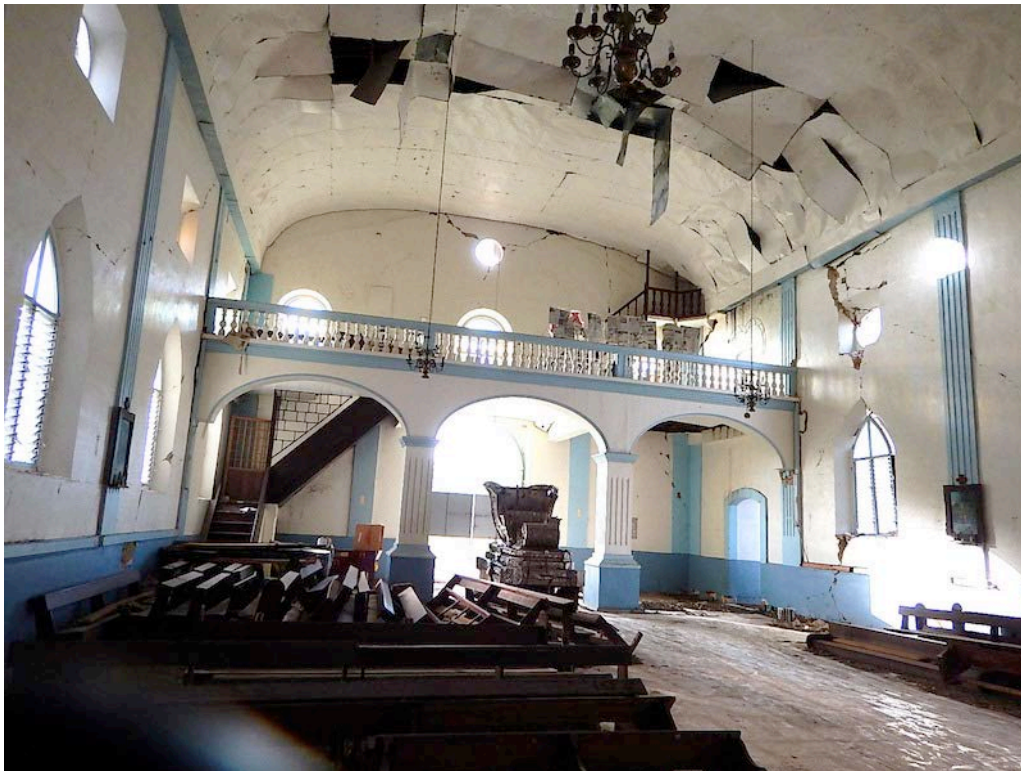
Figure 20. View of interior looking west towards the choir loft. Note the vertical and diagonal cracks on all the walls and the falling sheet metal ceiling.

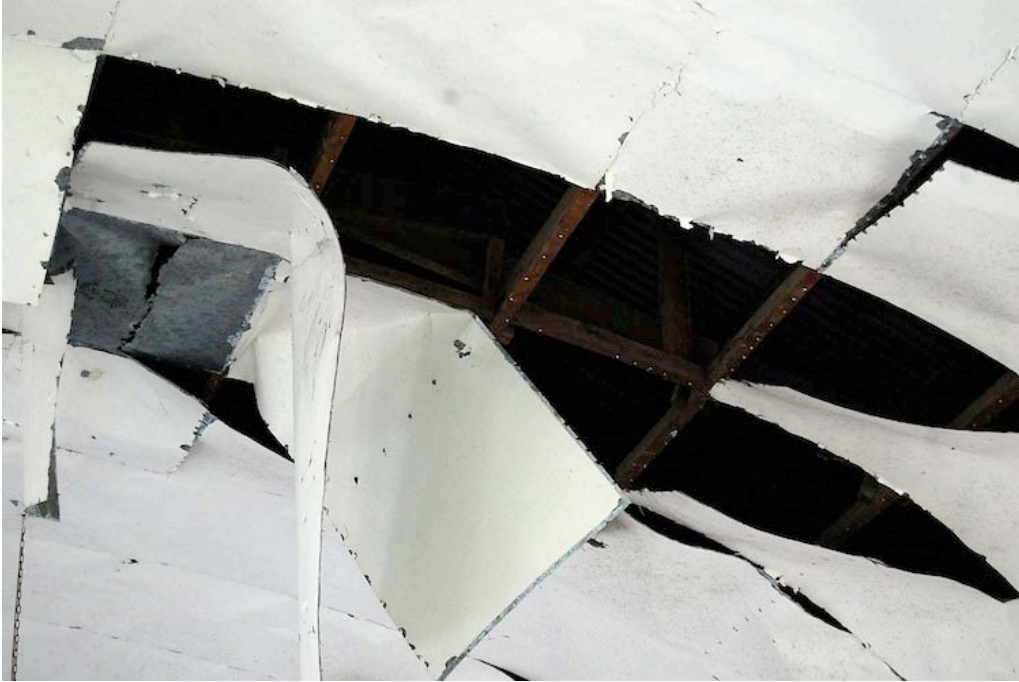
Figure 21. Close-up view of the ceiling area with exposed wood framing and falling sheet metal. Note that there are two layers of sheet metal ceiling and that the sheet metal has pulled through the fastener holes.

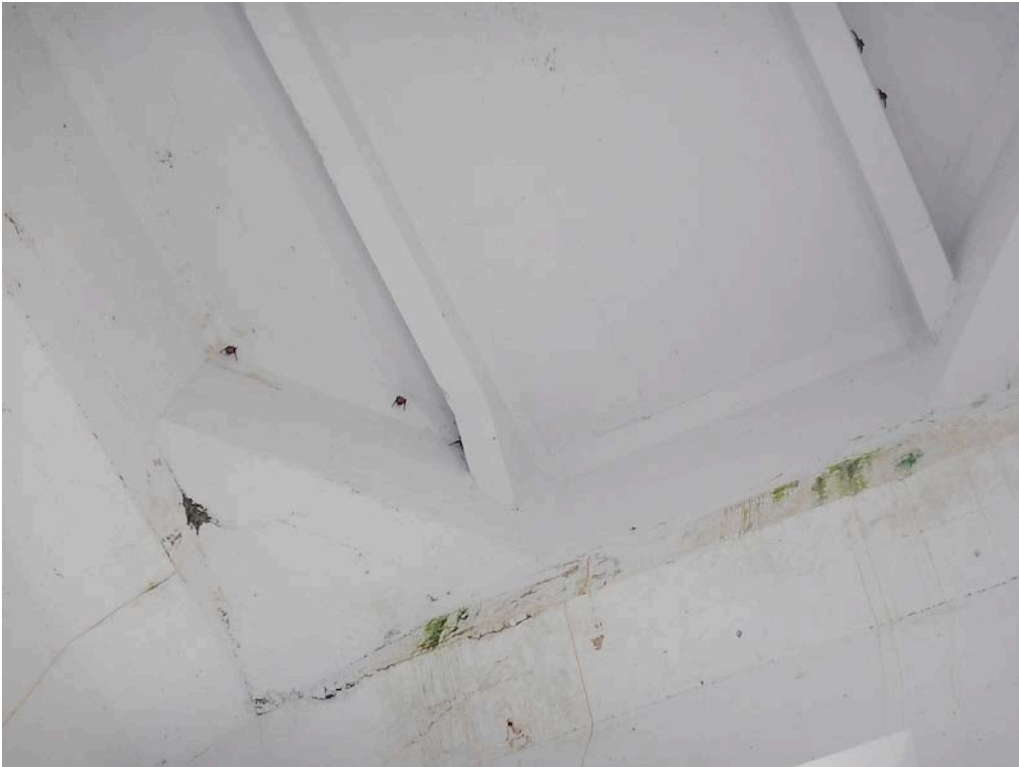
Figure 22. Underside of bell tower ceiling, showing that the construction is modern, with diagonals at the corners to resist twisting of the structure during an earthquake. Note the green stains from biological growth at leaks in the roof above.

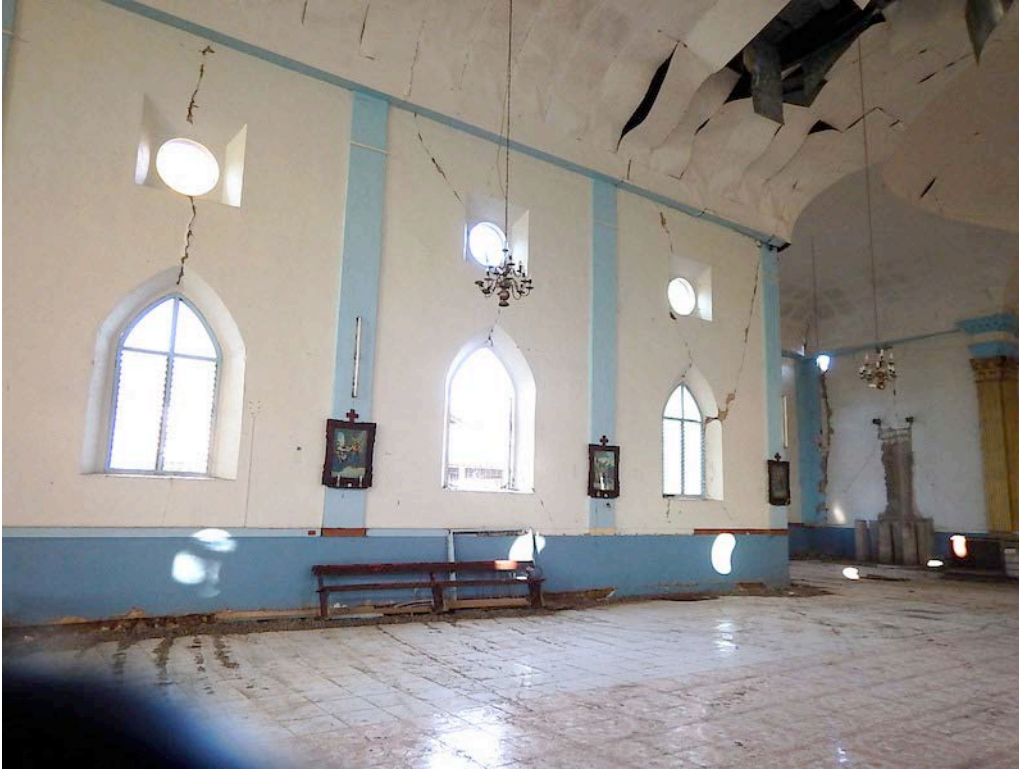
Figure 23. View of the north nave wall, showing pervasive vertical and diagonal cracks passing through the windows, which are a discontinuity in the wall.

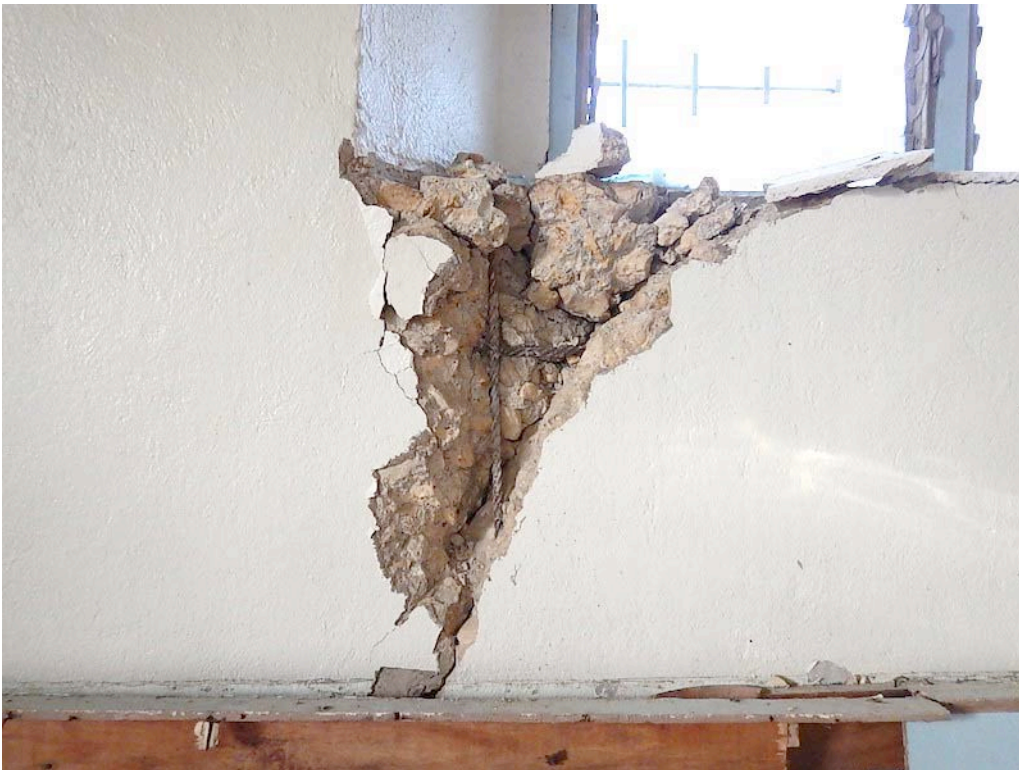
Figure 24. Close-up view showing steel reinforcing bars exposed by spalled concrete. These are twisted bars, which is a type common in the early 20th century. From spall locations like this it is clear that the concrete mix uses aggregate larger than recommended today, and that there are very few horizontal reinforcing bars.

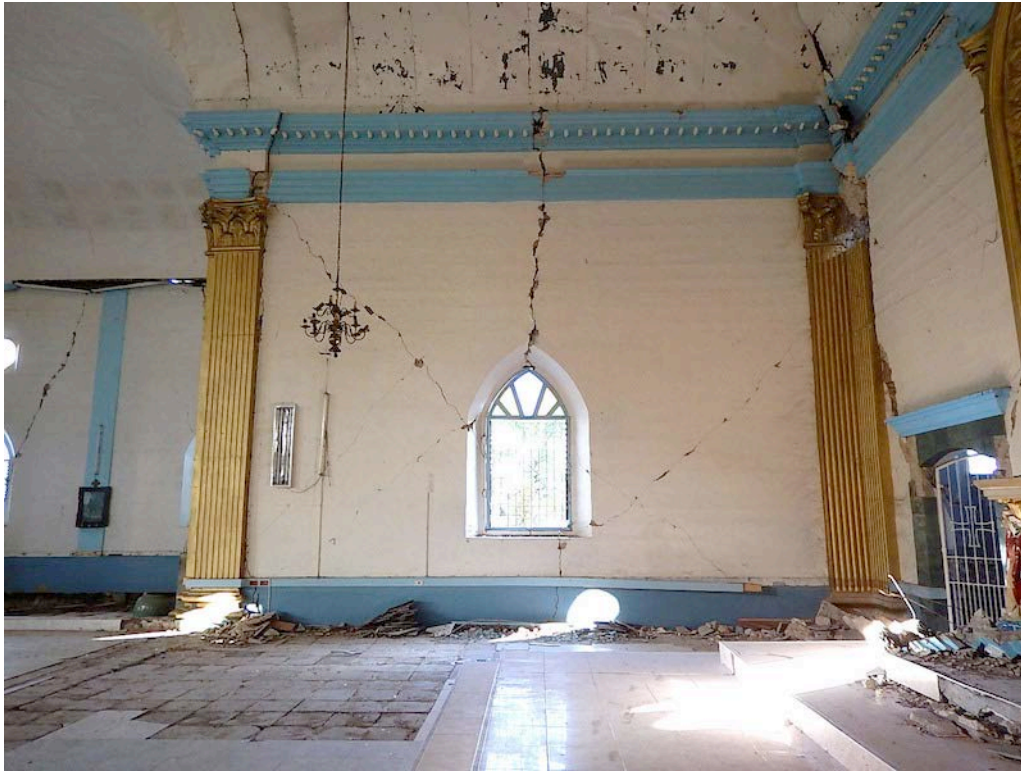
Figure 25. View of the north nave wall on the east side of the transept, showing damage similar to the other section of the north wall in fig. 23.

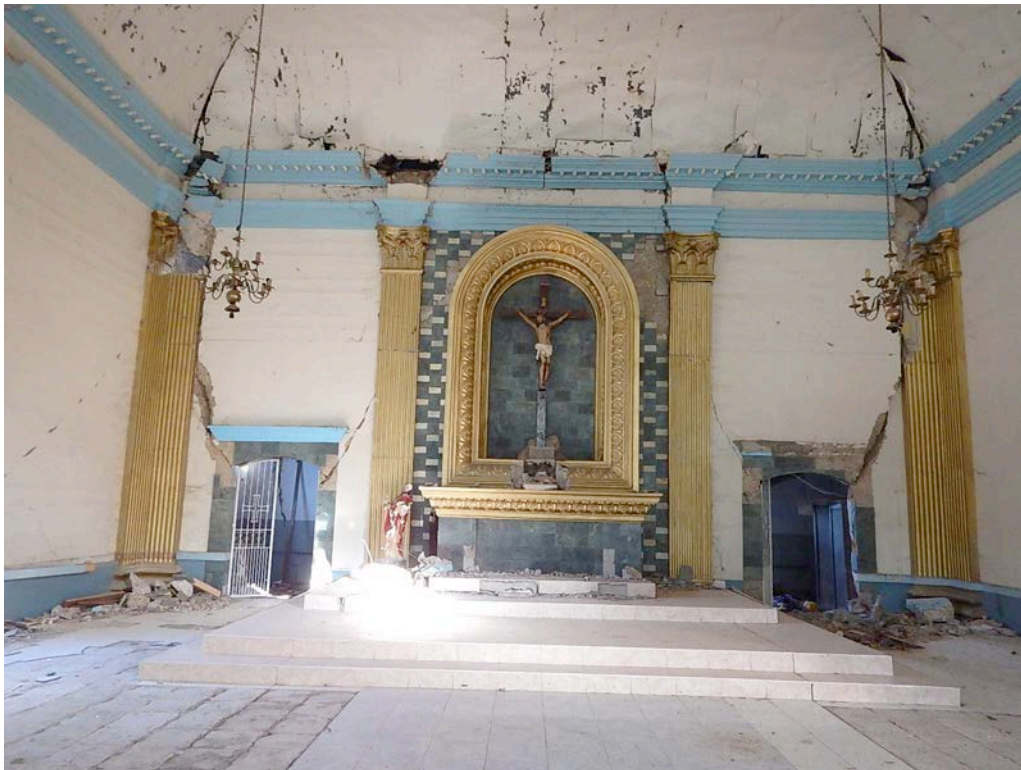
Figure 26. View of the altar wall, with diagonal cracks passing through the door openings.

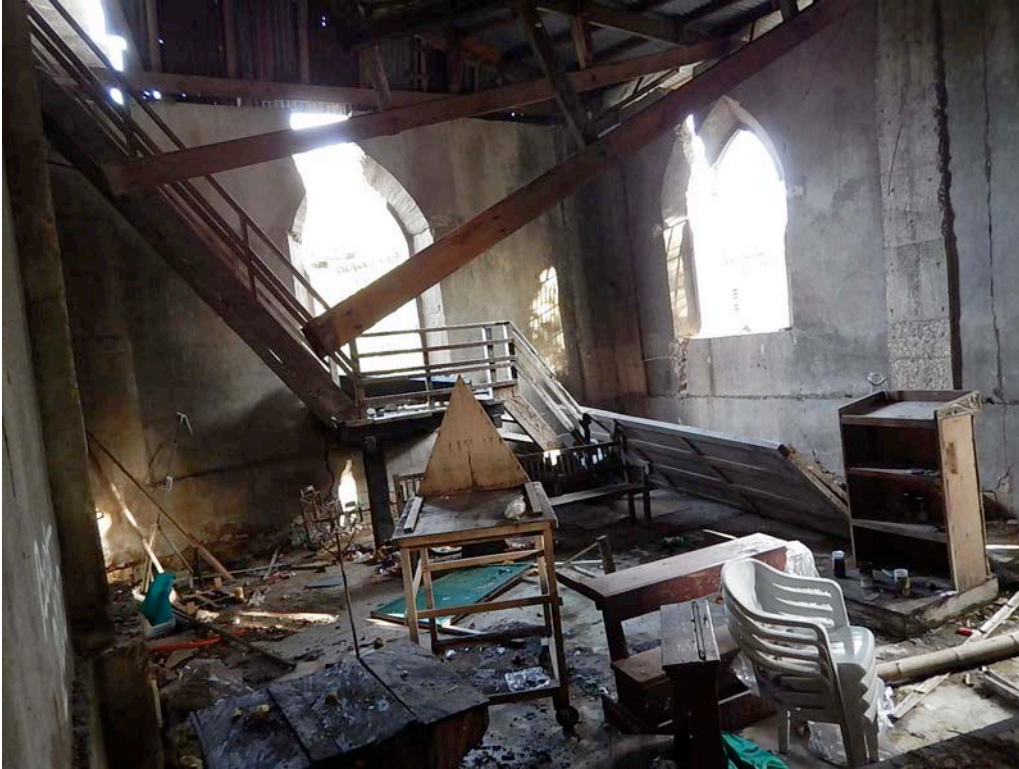
Figure 27. View of the southeast corner room, with collapsed roof structure, and cracked and displaced sections of concrete wall. See exterior view in fig. 17.

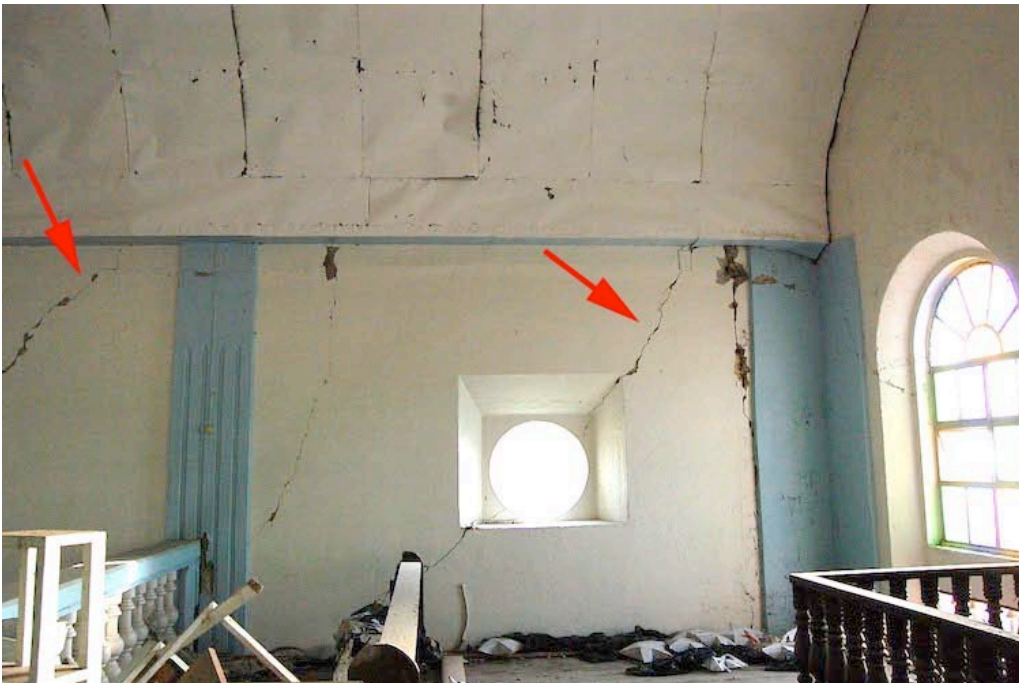
Figure 28. View of the southwest corner at the balcony level. The diagonal cracks at the arrows are the same exterior cracks shown in fig. 13. Note also a vertical crack at the left of the blue pilaster. All of the cracks appear to be the result of movement of the building and front facade to the west, and a possibly overturning of the front facade.

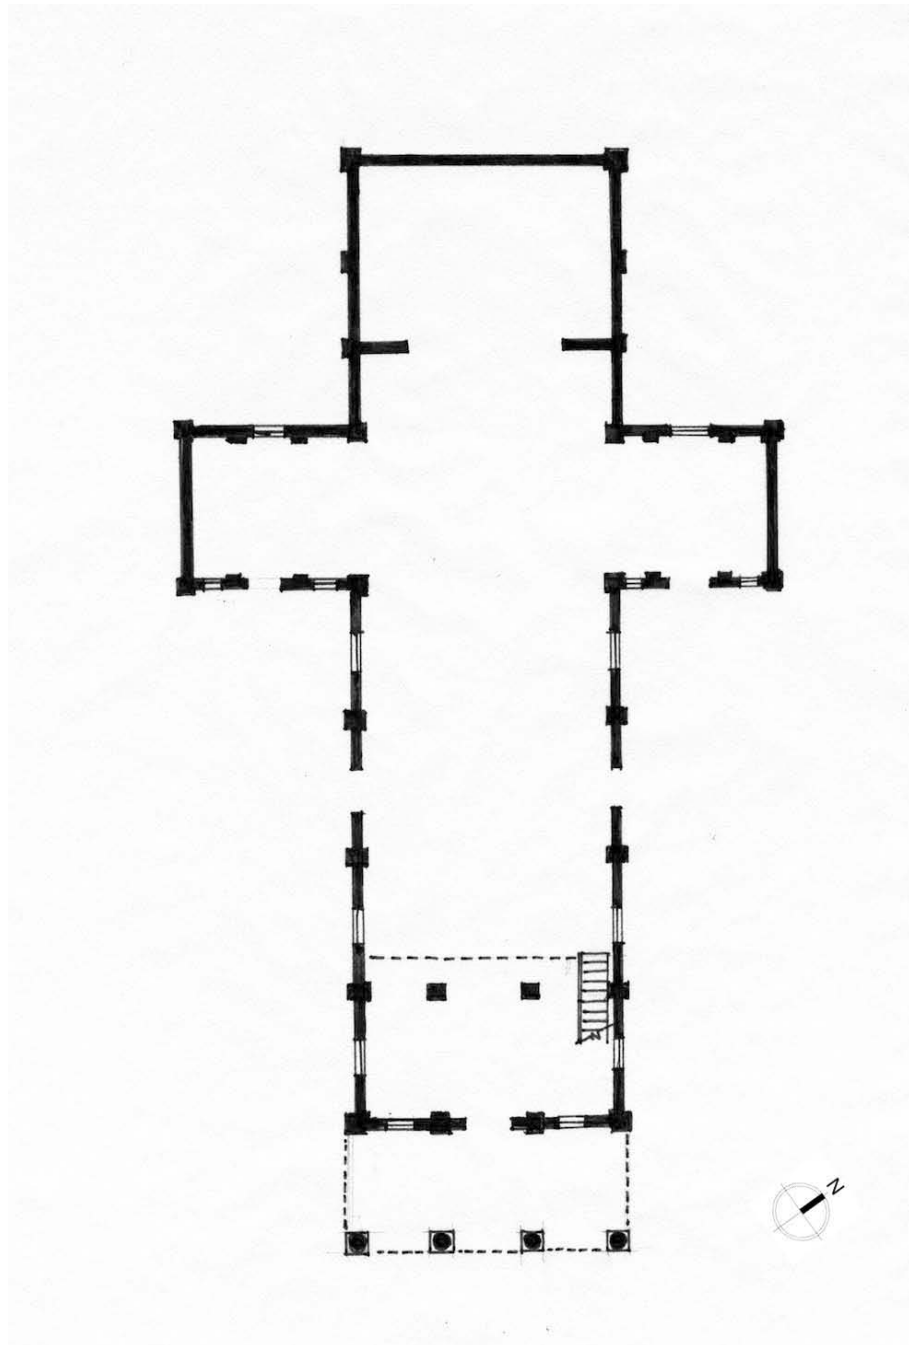
Figure 29. Ground floor plan of La Purisima Concepcion Church in Catigbian.

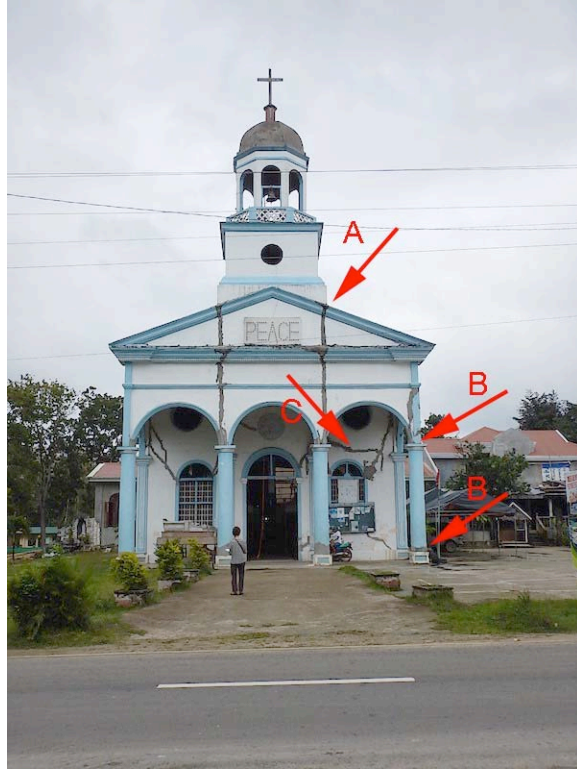
Figure 30. Front facade of the La Purisima Concepcion Church in Catigbian, built of reinforced concrete during the 1930s, and likely completed after WWII. The temple-front facade is typical of the churches in smaller towns of Bohol. Note recently patched vertical cracks at “A,” diagonal cracks at “B,” and cracks at the column top and base at “C.” See details and discussion in the following figures.

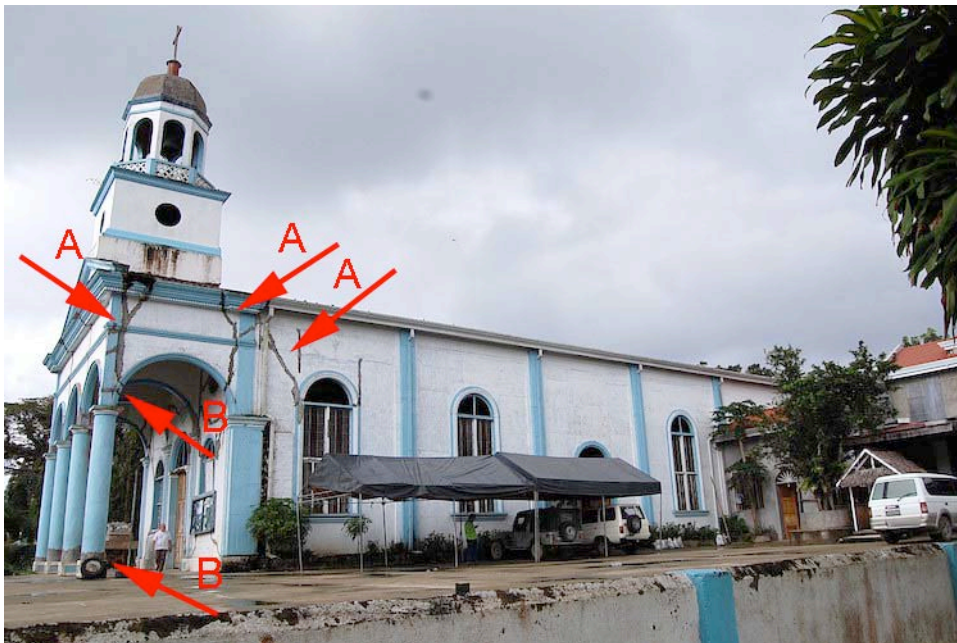
Figure 31. View of the north side of the portico and bell tower and north elevation. The cracks at “A” appear to be from rocking of the portico and bell tower from soft-story and mass irregularities. The cracks at “B” are from bending of the columns during the portico rocking motion.

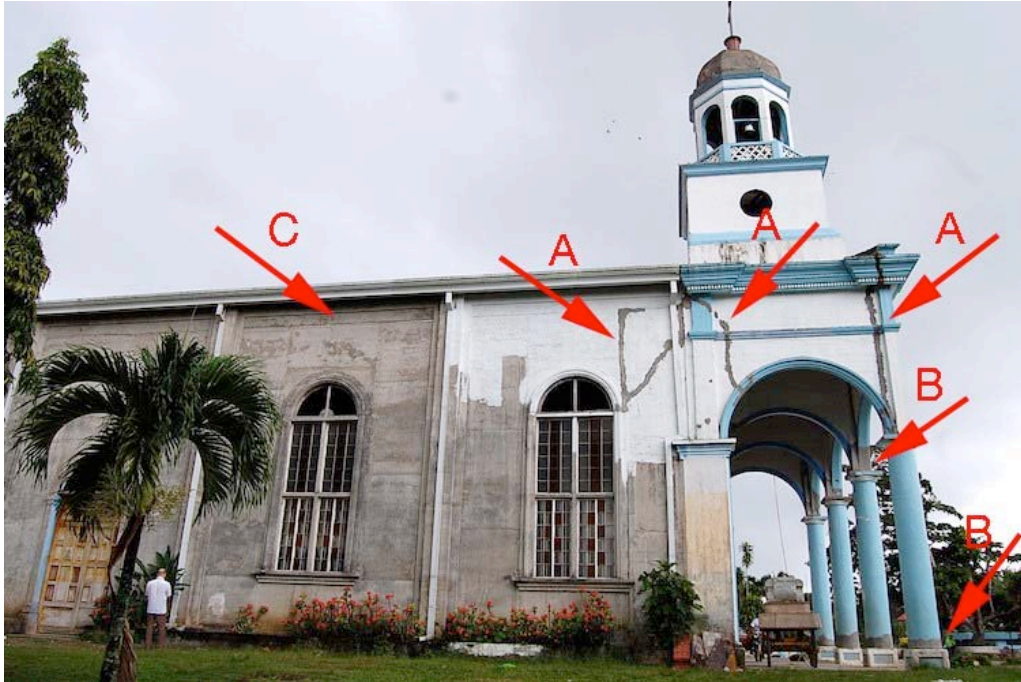
Figure 32. View of the south side of the portico and bell tower and partial south elevation. The cracks at “A” and “B” match those in the previous figure. At “C” can be seen what appears to be a beam connecting the tops of the frame columns. See interior view of beam in fig. 43.

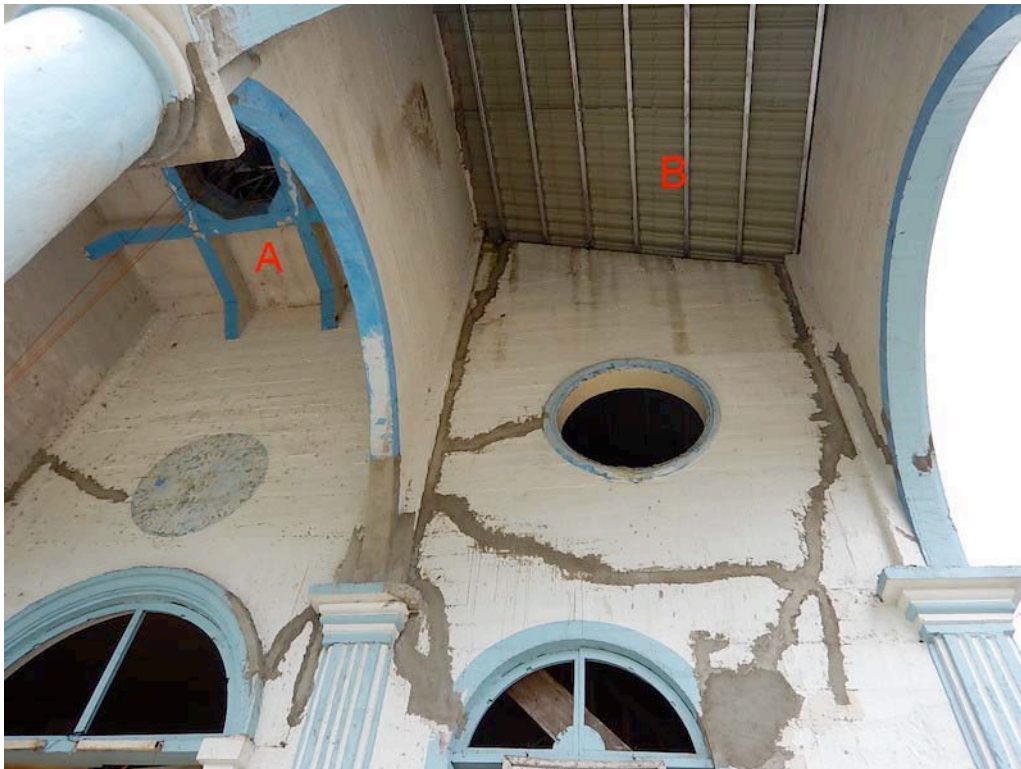
Figure 33. Facade and underside of portico, showing recently patched concrete, which is recommended to be monitored for durability. At the central bay at “A” can be seen the framing for the floor of the bell tower, which has haunches where the beams meet the walls, and diagonals in the corners, both modern concrete details designed to resist rocking and twisting during earthquakes. At “B” is the underside of the roof, which indicates that the two outer bays of the portico are less rigid and can twist during an earthquake.

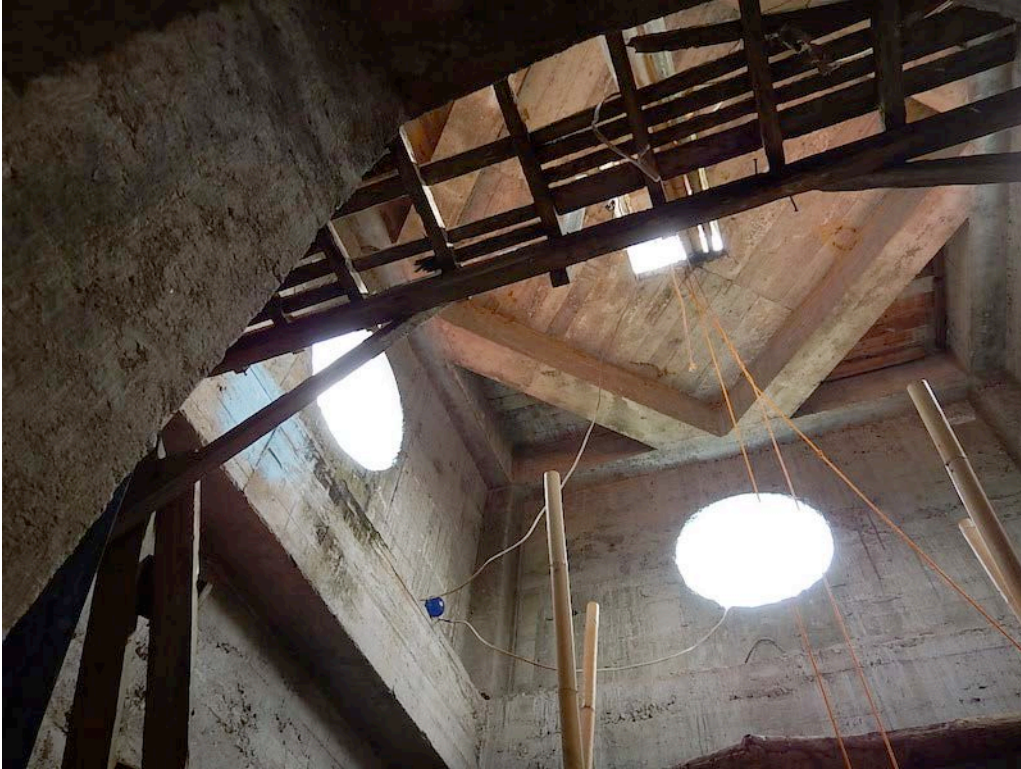
Figure 34. Interior view of the bell tower, underside of portico, showing the diagonal beams in the floor framing, which are designed to resist twisting during earthquakes.
