BAKÁS PILIPINAS

PHILIPPINE HISTORIC PRESERVATION SOCIETY

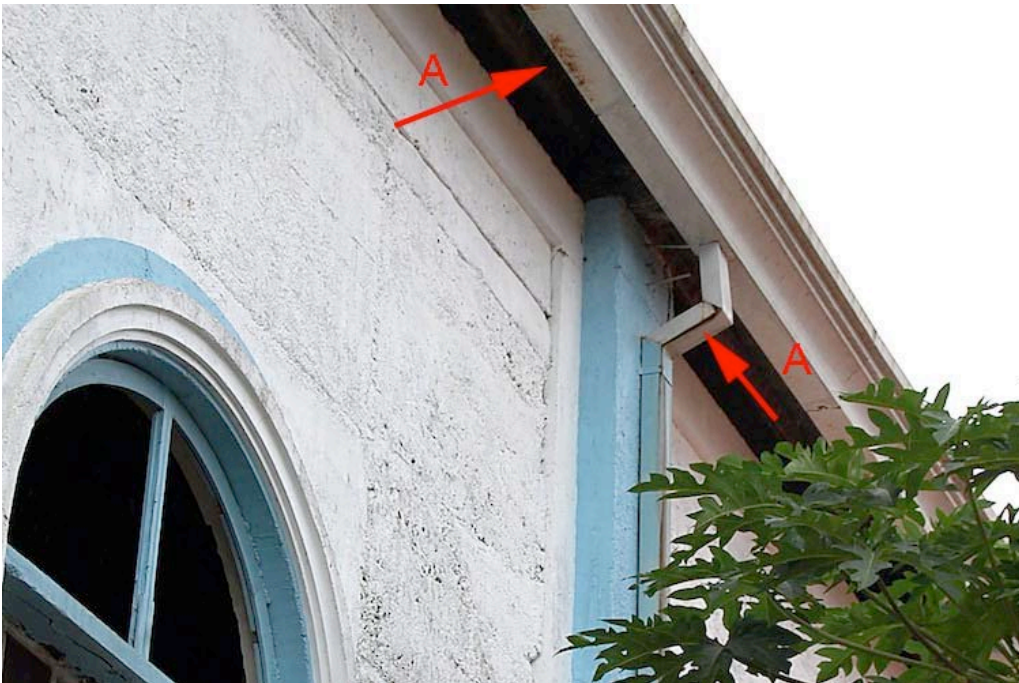
Figure 37. Underside of the metal gutters, showing rusting, and open joints and rusting of the downspouts.

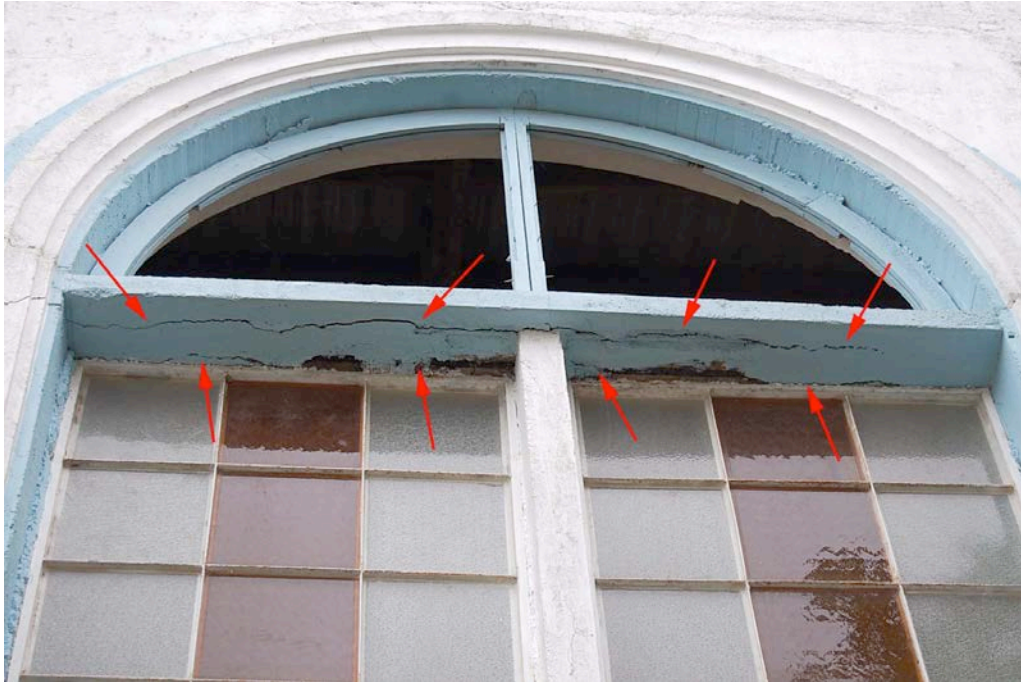
Figure 38. Typical view of steel casement windows with colored glass. The arrows point to cracks in the concrete transom bar, probably caused by rusting steel reinforcing bars, which is not seismic damage.

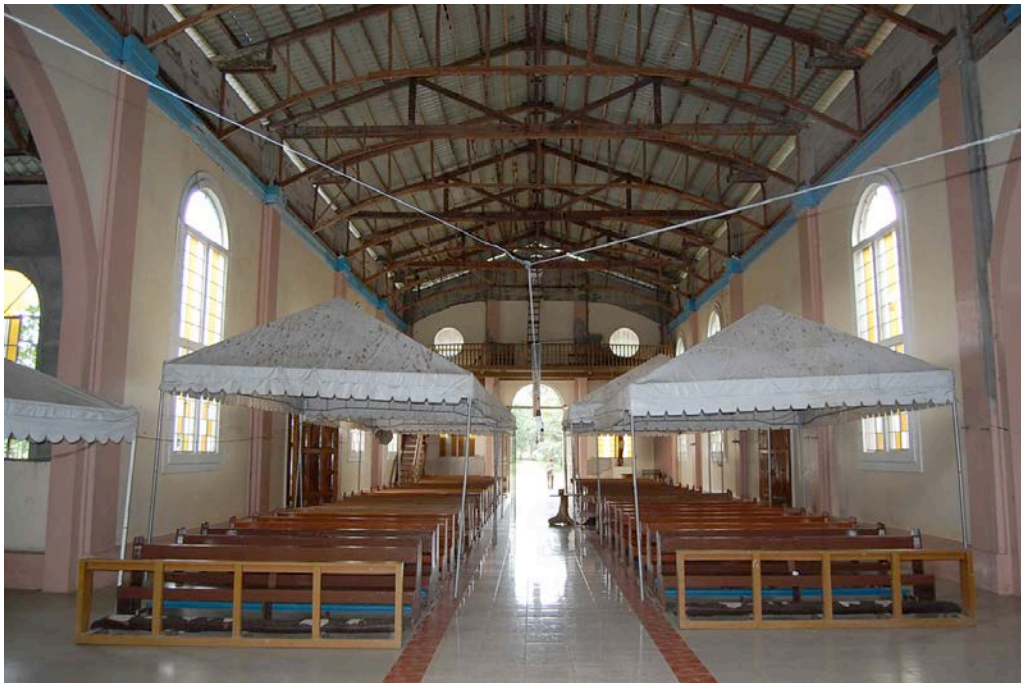
Figure 39. View of the sanctuary interior looking towards the entrance and choir loft above. Note the tents to protect from rainwater and bird guano.

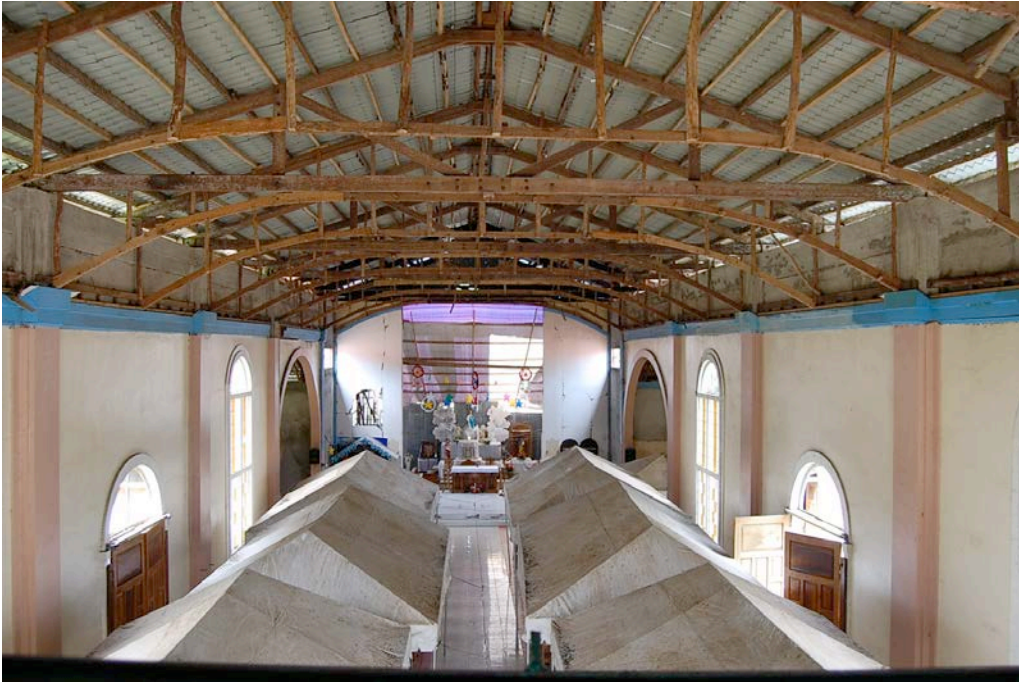
Figure 40. View from balcony looking towards the altar. Note the missing finished ceiling, exposing the lightly framed roof structure.

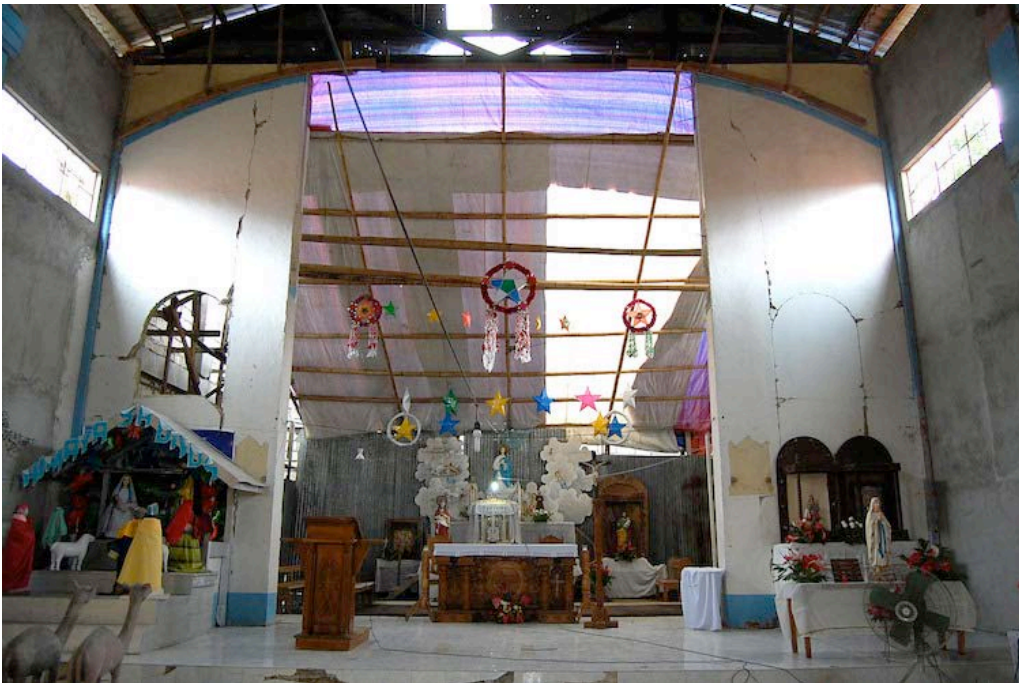
Figure 41. View of the altar, showing cracks and collapsed sections.

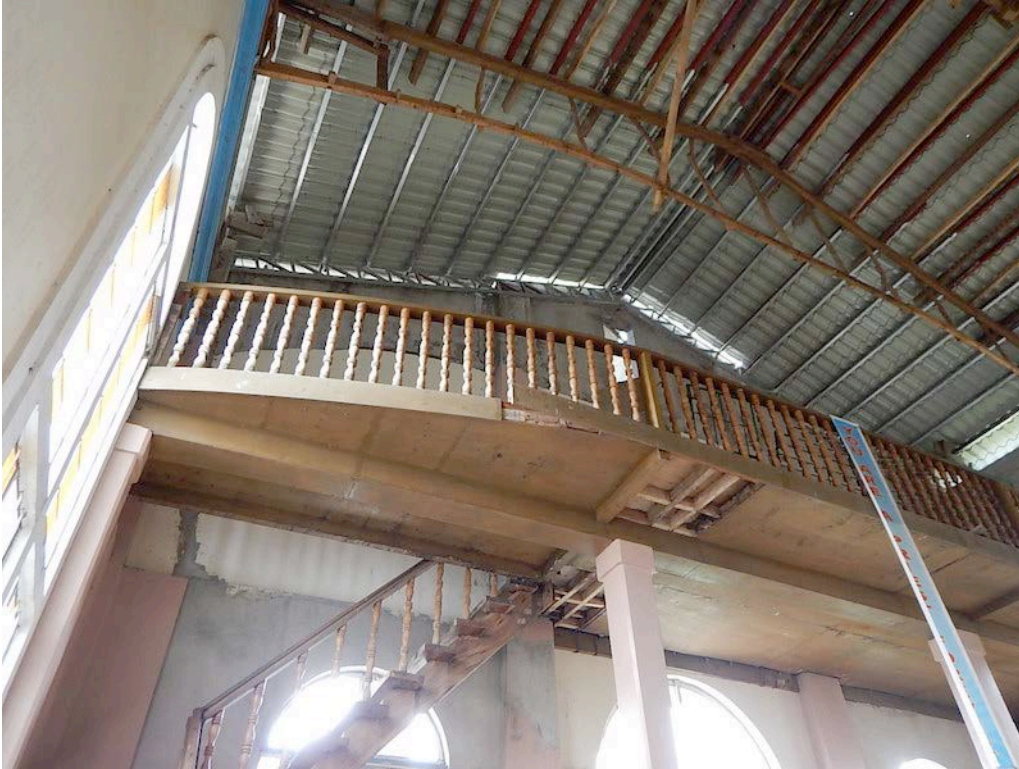
Figure 42. View of the choir loft. Note missing plywood panel ceilings, and steel roof purlins in one section of the roof.

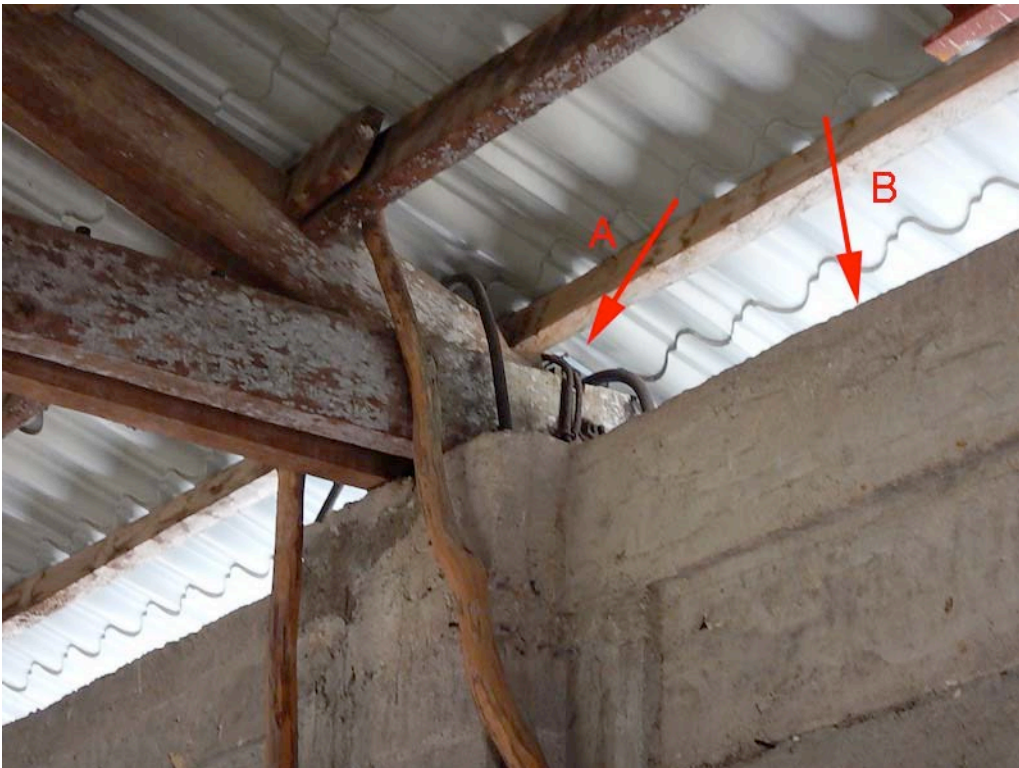
Figure 43. Close-up view showing trusses bearing on the concrete columns and fastened to the concrete with bent iron bars at "A." Note the beam at "B," which can be seen on the exterior in fig. 32.

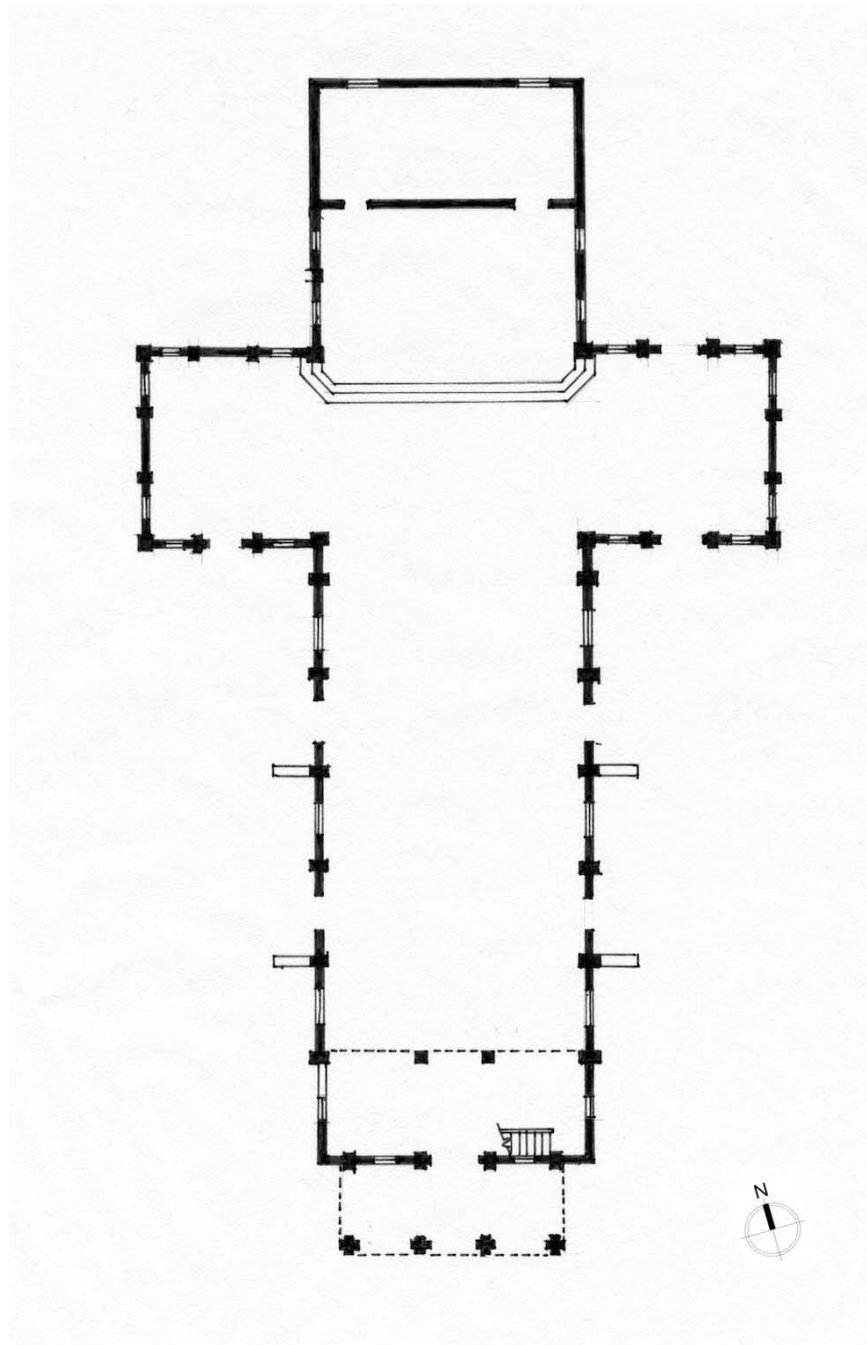
Figure 44. Ground floor plan of San Antonio de Padua Church in Sikatuna.

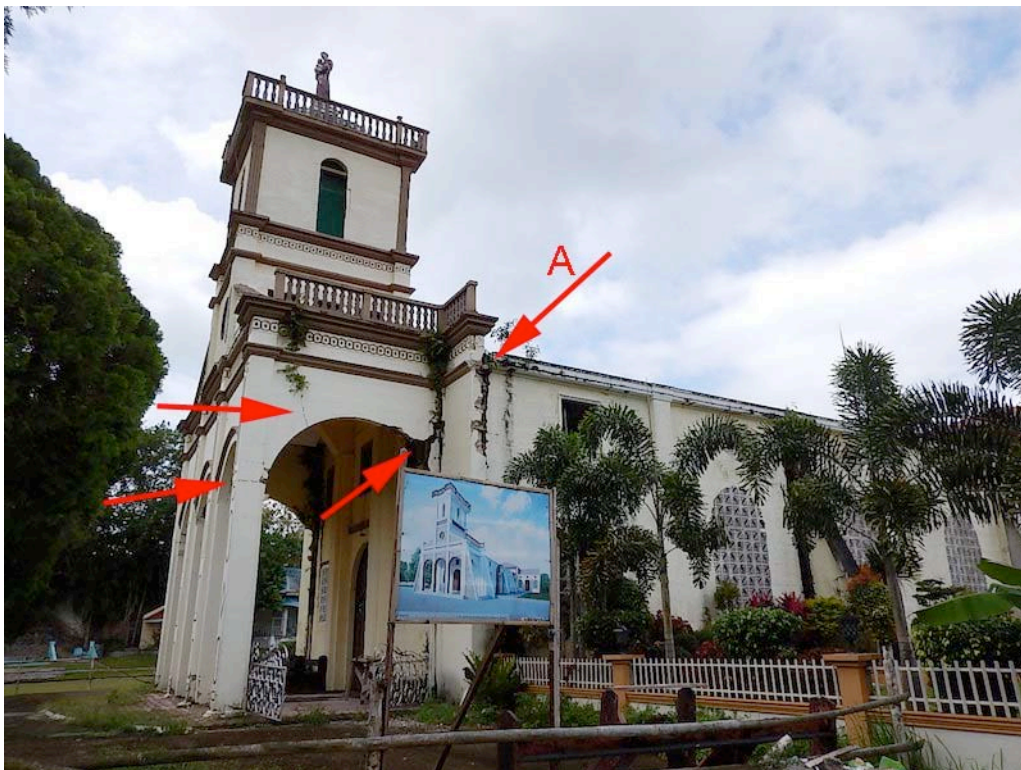
Figure 46. View of east side of the portico and bell tower, with the arrows pointing to crack, which all appear to be from rocking of the bell tower and portico. See fig. 58 for interior view of the crack at "A."

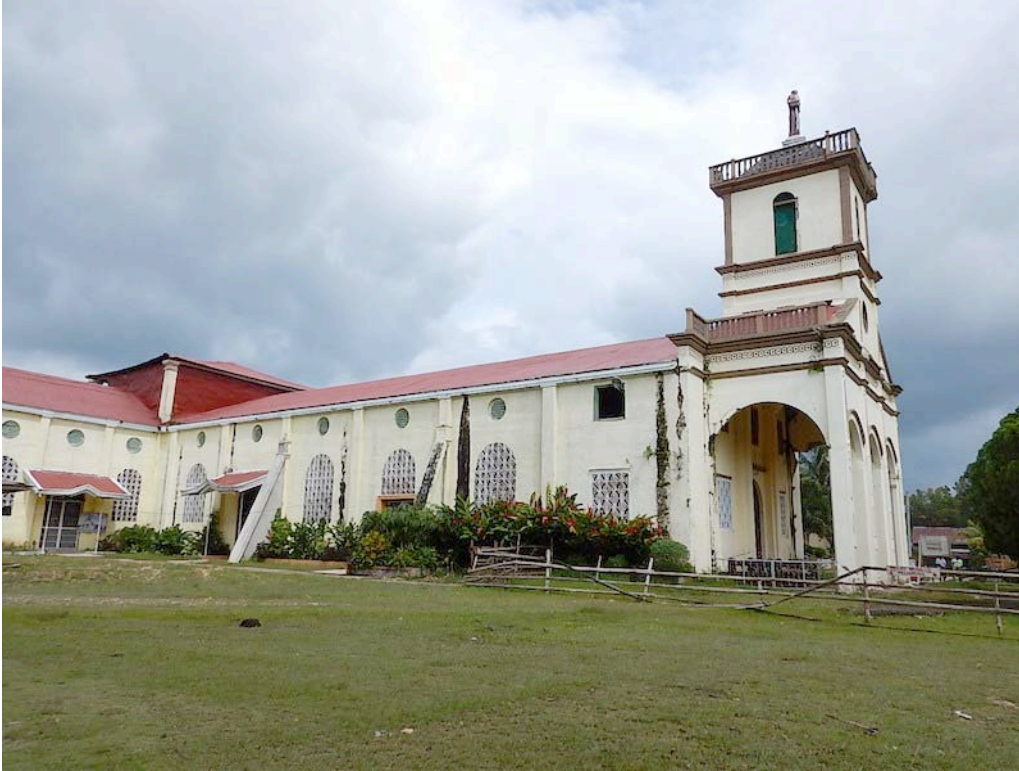
Figure 47. View of west elevation. Note the concrete buttresses that have been added to the original structure. The left buttress was recently constructed. See following figures for details.

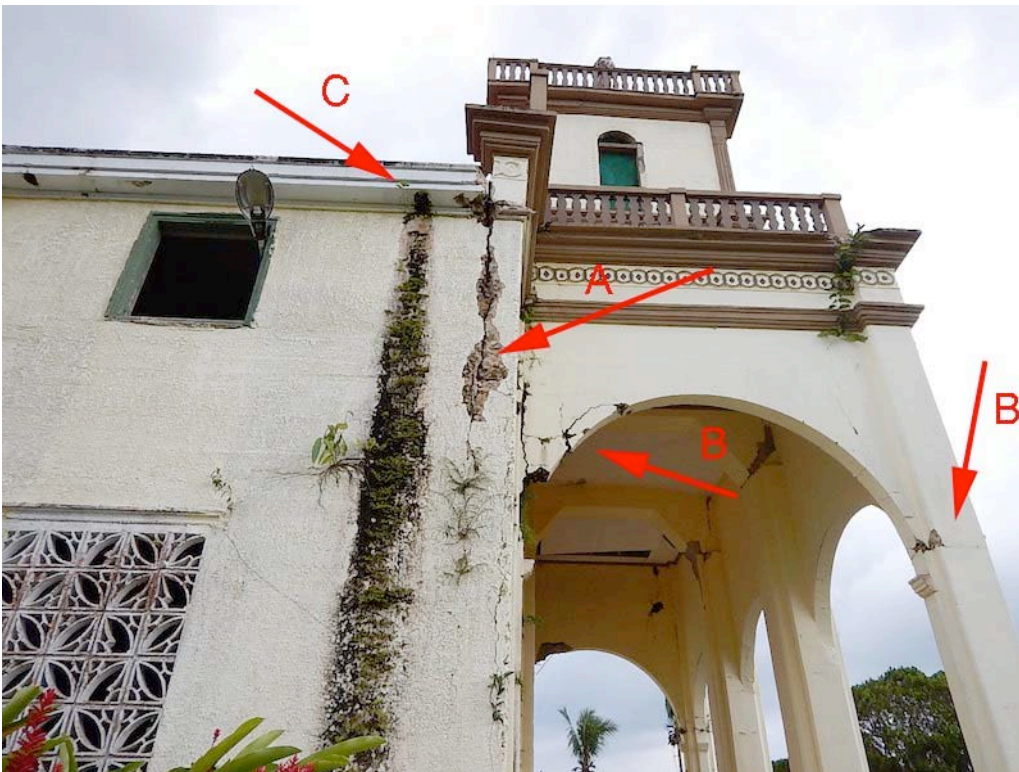
Figure 48. Detail of figure above, showing at "A" vertical crack and hinge cracks at "B," both from rocking of the portico. At "C" is a gutter outlet, which is missing its downspout, and significant plant growth from excessive water saturation of the concrete. See details in the following figures.

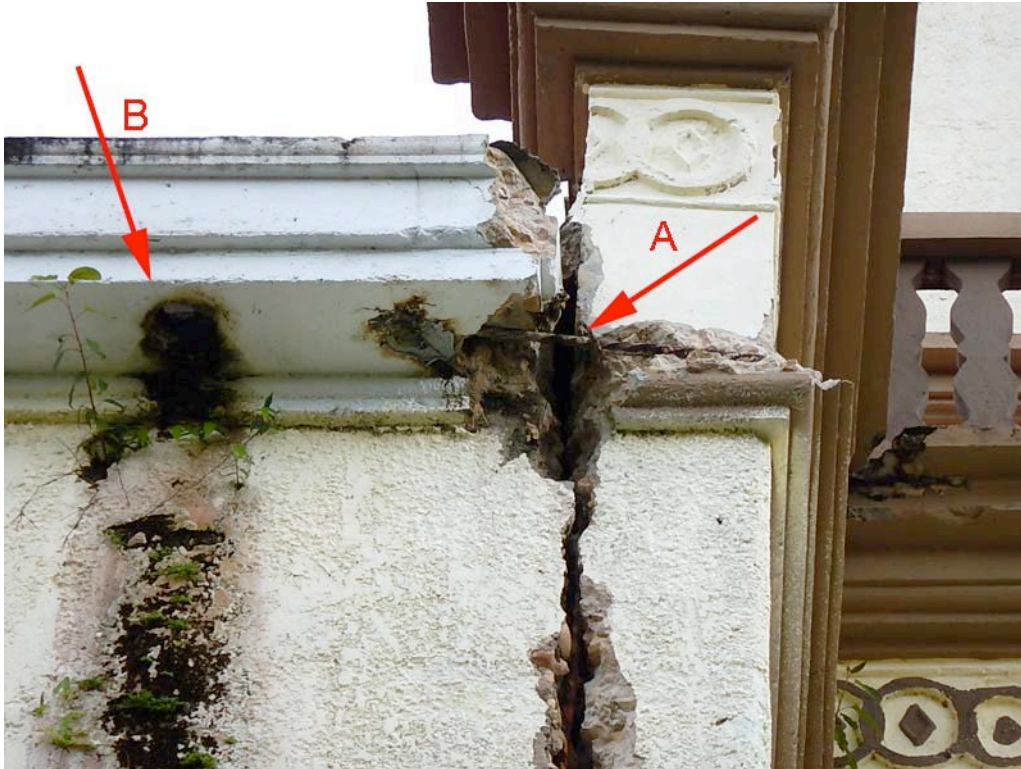
Figure 49. Detailed view of the crack at the southwest corner. Note the reinforcing bar at “A,” which appears to be for the cornice. At “B” is a gutter outlet, which is missing its downspout, and has caused extensive plant growth on the wall and in cracks in the wall.

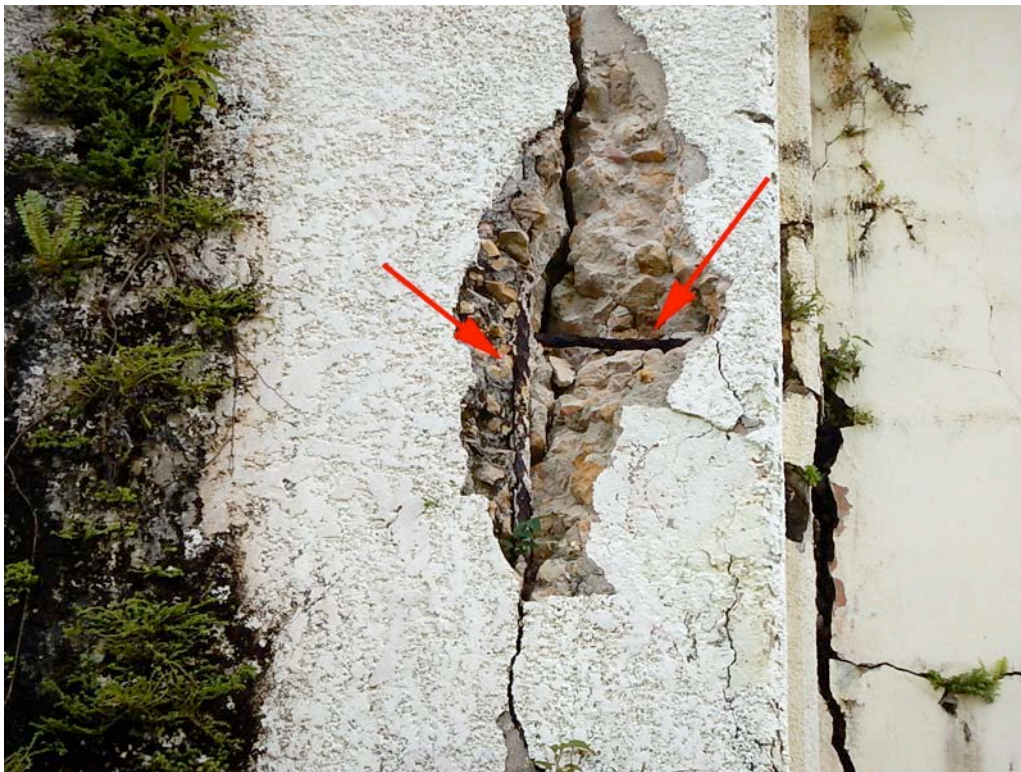
Figure 50. Detailed view of the crack at the southwest corner, showing exposed twisted reinforcing bars, and also exposed concrete with reveals large aggregate.

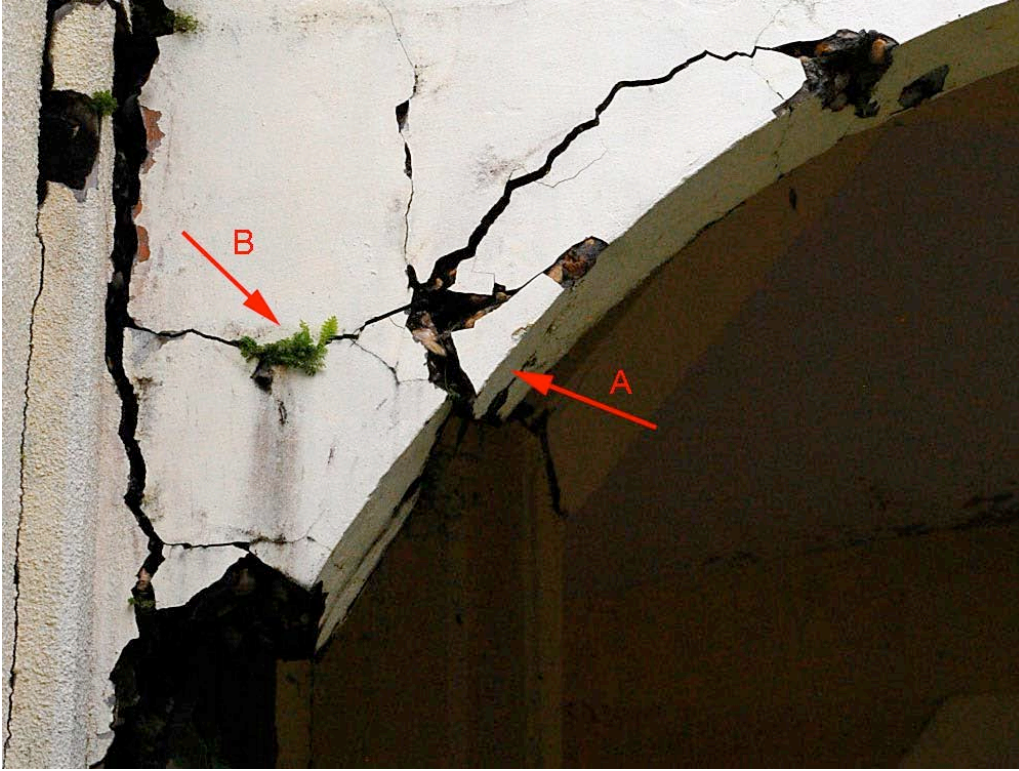
Figure 51. Detail of west portico arch at front facade, showing vertical cracks on the left, loose concrete at “A” (which is a safety hazard), and ferns growing in the crack at “B.”

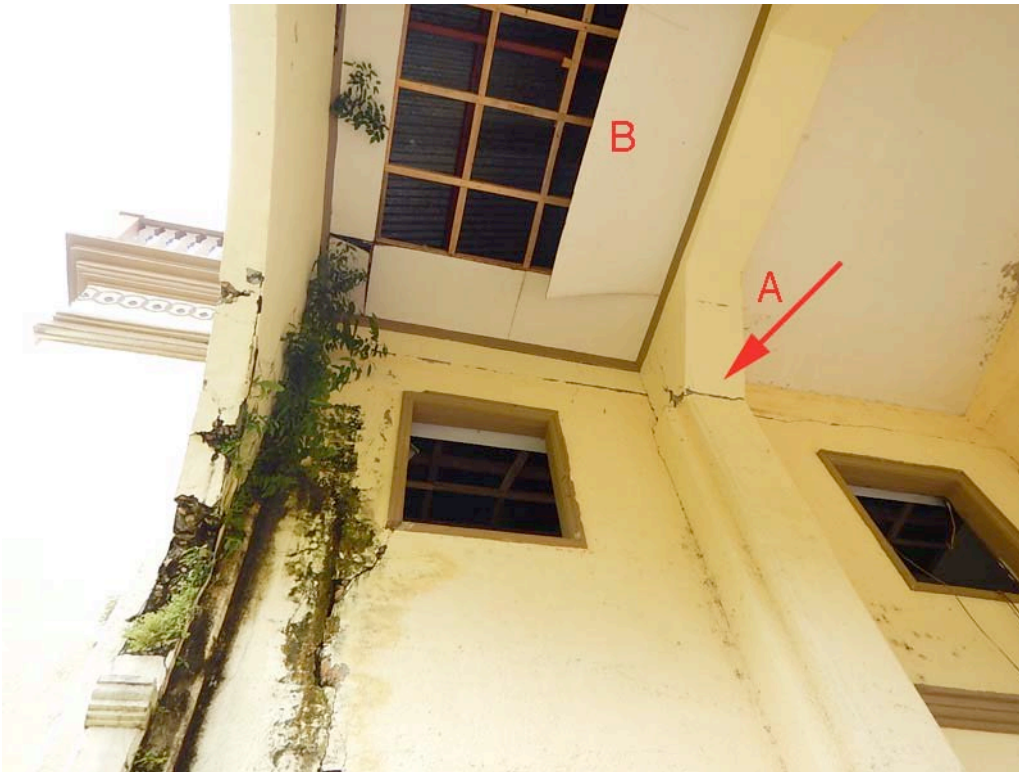
Figure 52. View of the front facade at the southwest corner. Note cracked concrete at haunch at “A,” and fallen ceiling sections at “B.” The roofing can be seen above the ceiling, indicating that the portico structure is similar to Catigbian (see fig. 33), so prone to twisting during an earthquake.

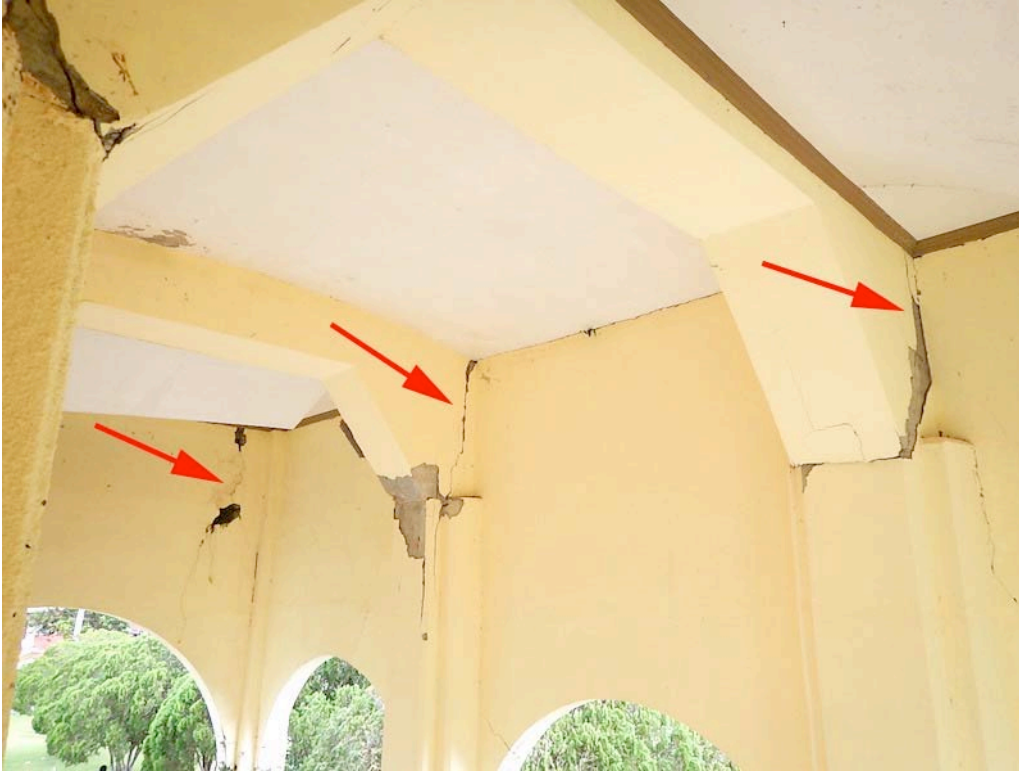
Figure 53. View beneath the portico. Note the cracks around the beam haunches from rocking of the portico and bell tower.

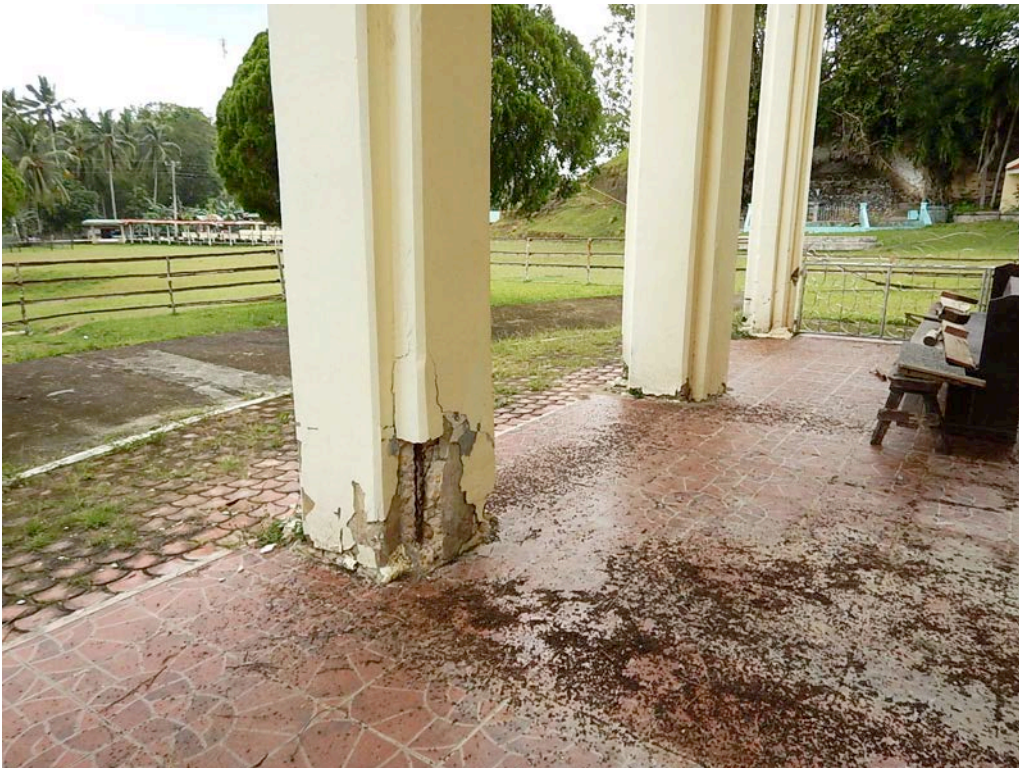
Figure 54. Concrete portico columns are typically cracked and spalled at the bases from bending. This is a common damage type for portico rocking caused by a soft-story and mass irregularity such as a bell tower.

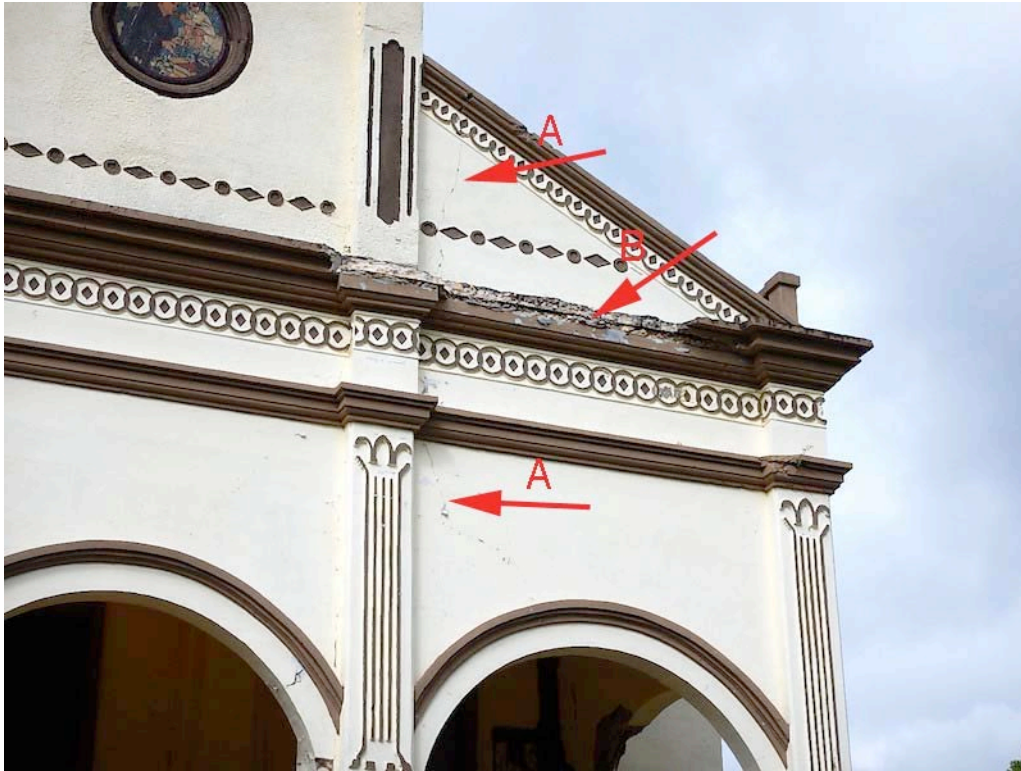
Figure 55. East side of the portico, showing vertical cracks at “A,” similar in location to cracks found in the portico at Catigbian (see fig. 30). Also, part of the cornice molding at “B” has fallen, exposing the reinforcing bar.

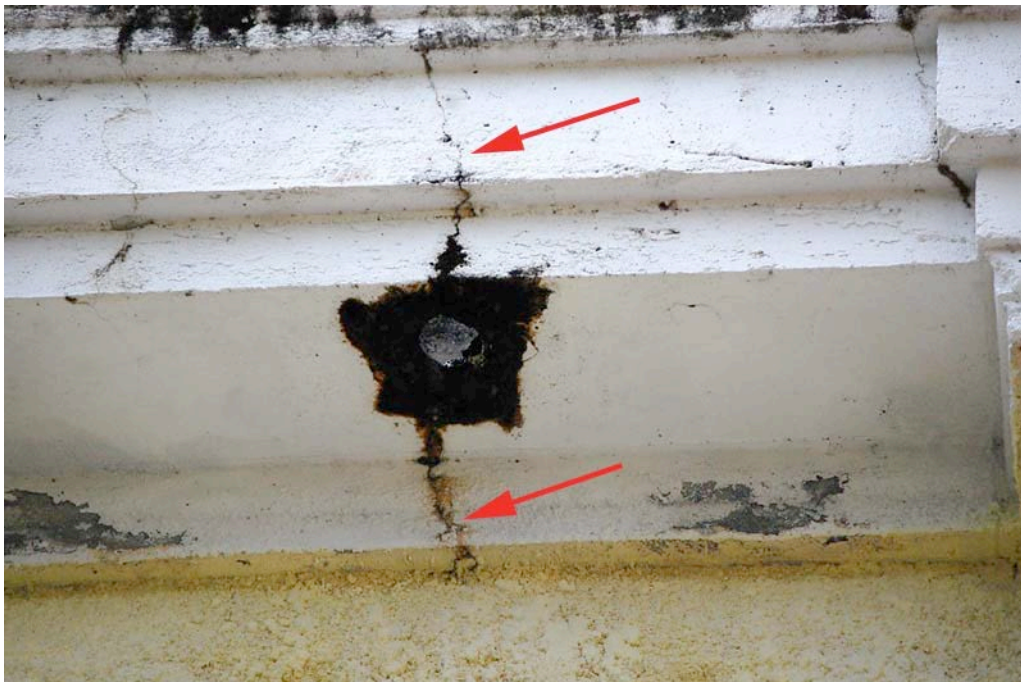
Figure 56. Crack in the gutter cornice at the gutter outlet, which appears to be from rusting iron, and not from seismic damage.

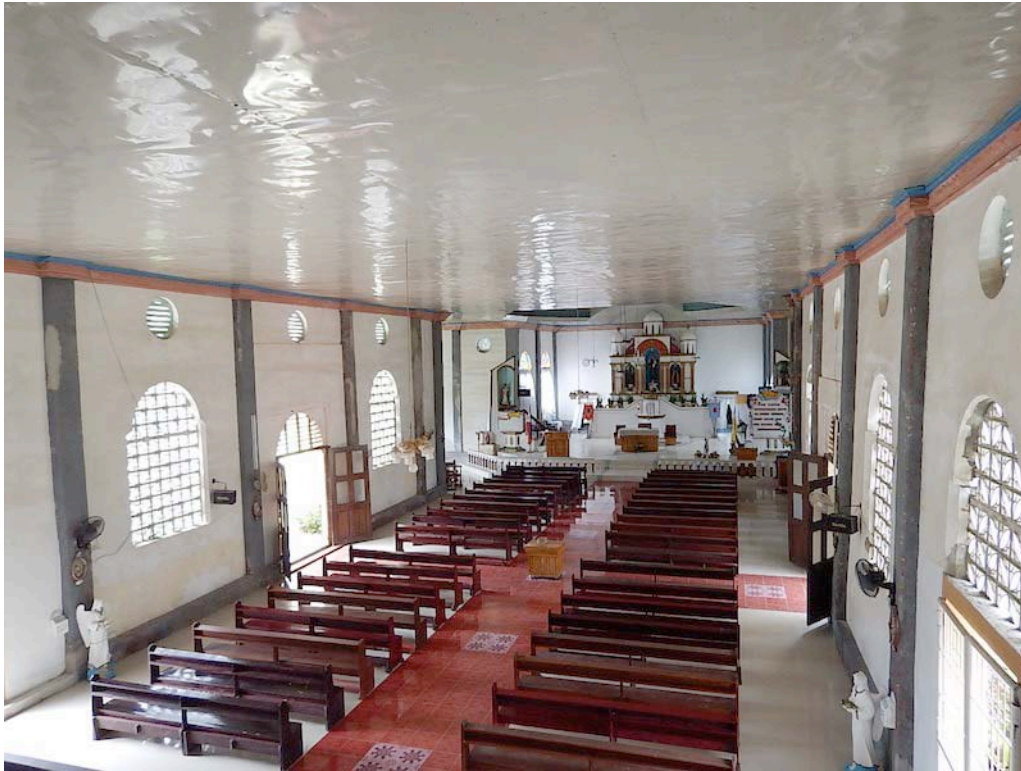
Figure 57. View of the interior from the choir loft. The ceiling appears to have been recently replaced.

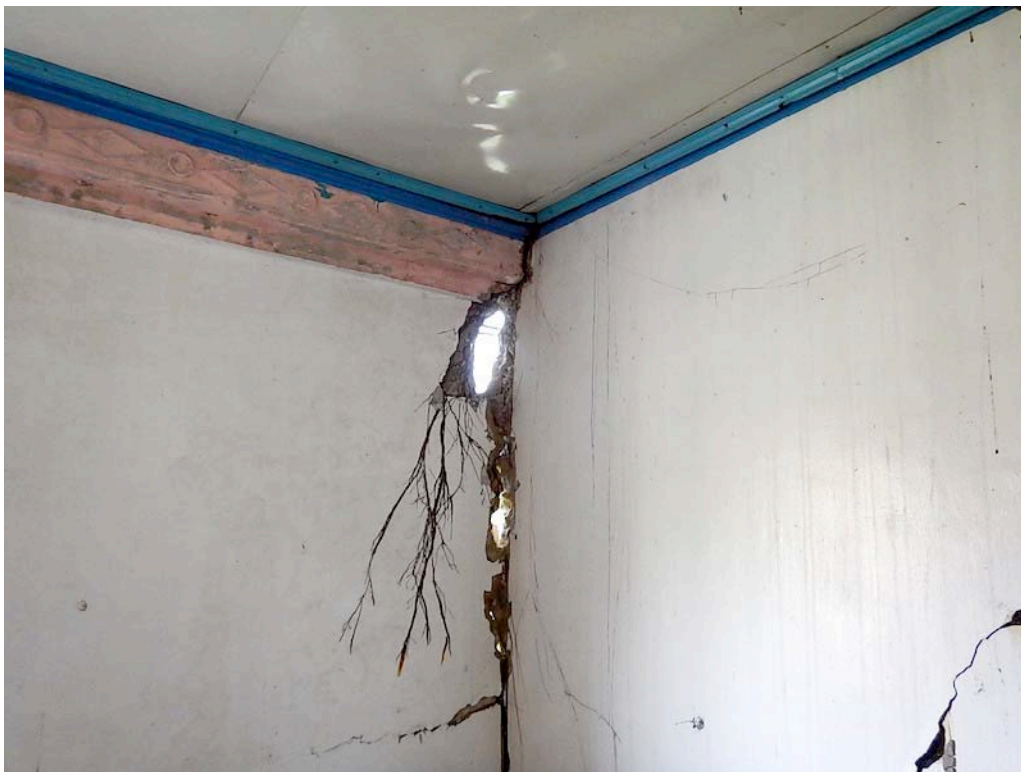
Figure 58. Close-up view of the southeast corner crack from the interior. Compare with fig. 46. At this location it can be seen that the reinforcing bars are of small size and inadequately spaced. Note also plant roots from plants growing on the exterior.

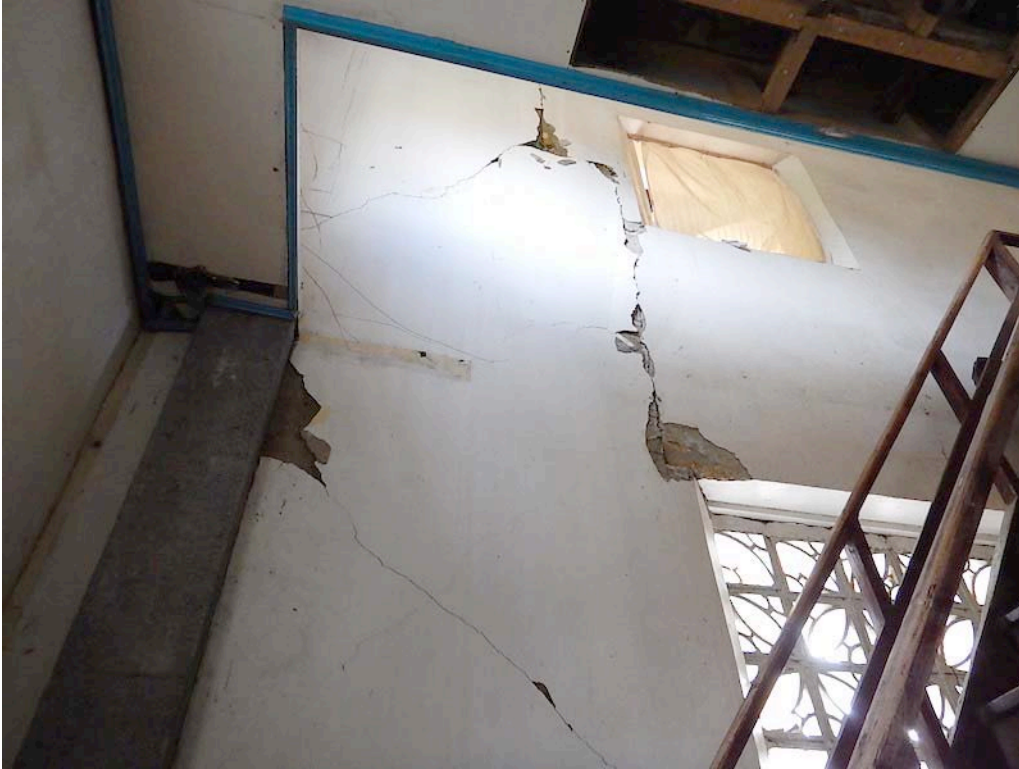
Figure 59. View of the inside face of the front facade at the choir loft. The vertical cracks appear to be at the boundary between construction phases, and extend through the exterior.

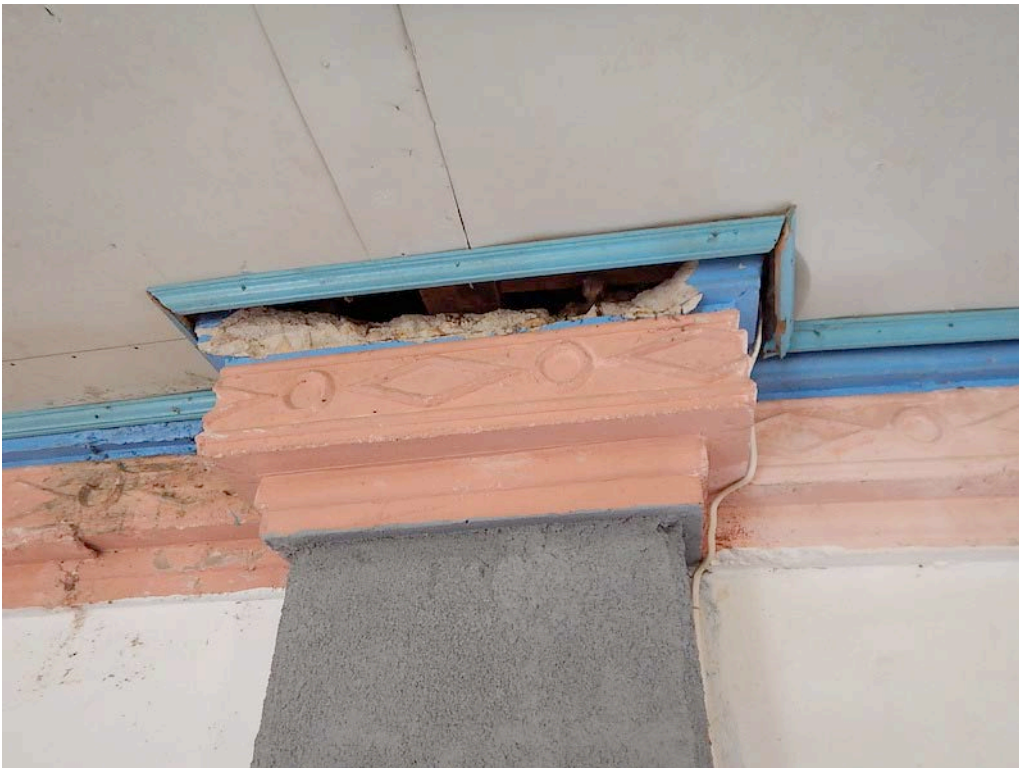
Figure 60. The interior pilaster or concrete capital shows damage of its top molding, possibly from seismic movement of the ceiling, or during the ceiling reinstallation.
